Test documentation 2020-108

Experimental examination on the
load bearing capacity of a seam clamp
for the roof covering Craft.Lock of the
manufacturer Clotan Steel

December 2020

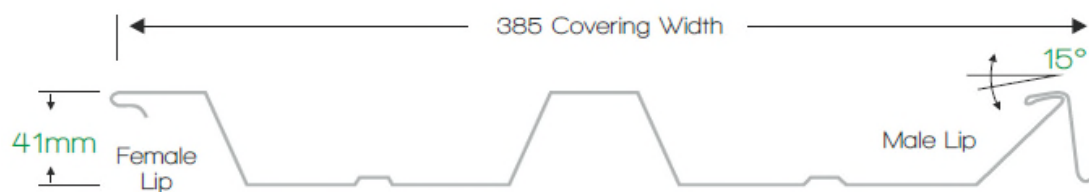
Fig. 1 schematic display of the profile cross section

Subject of the present test report are experimental investigations to determine the load bearing capacity of specific seam clamps for the industrially produced roof covering of the manufacturer Clotan steel with the product name Craft-Lock. The profile is a concealed fix roofing deck with a specific width of 385 mm, which is fixed in the longitudinal joints by fasteners on the supporting structure of the roof (purlins or battens) or on the roof boarding. The profile manufactured by roll forming has different top chord geometries in the middle of the profile and at the longitudinal joints. Since the upper chord does not have a back slope in the middle of the profile, a clamp fastening is not possible. As a result, a seam clamp can only be fixed on the longitudinal joints.

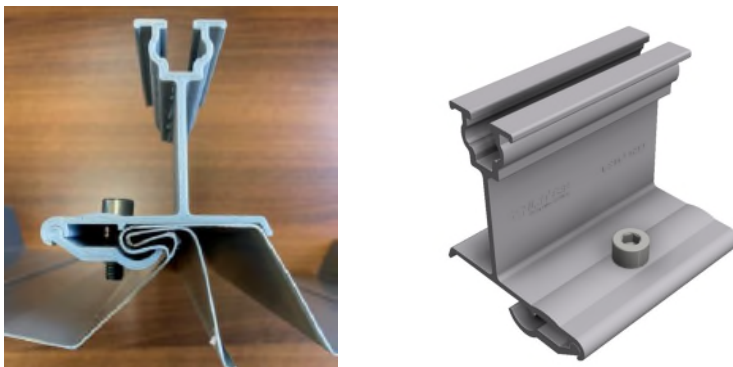
Fig. 2 isometric display of the seam clamp

Fig. 2 shows the seam clamp for the specific geometry of the Craft.Lock profile. This clamp has two legs, one of which encloses the overlapping area of the profiles and the other one fixing the clamp to the profile joint with the screw tightening, thus creating a force and form locking. Tensile and pressure forces are thus introduced directly into the profile.

Shear forces parallel to the upper chords of the sheet metal resulting from the slope downforce of the solar generator are transmitted by friction. It is thus essential that the screw is tightened with a defined torque of 15 Nm.

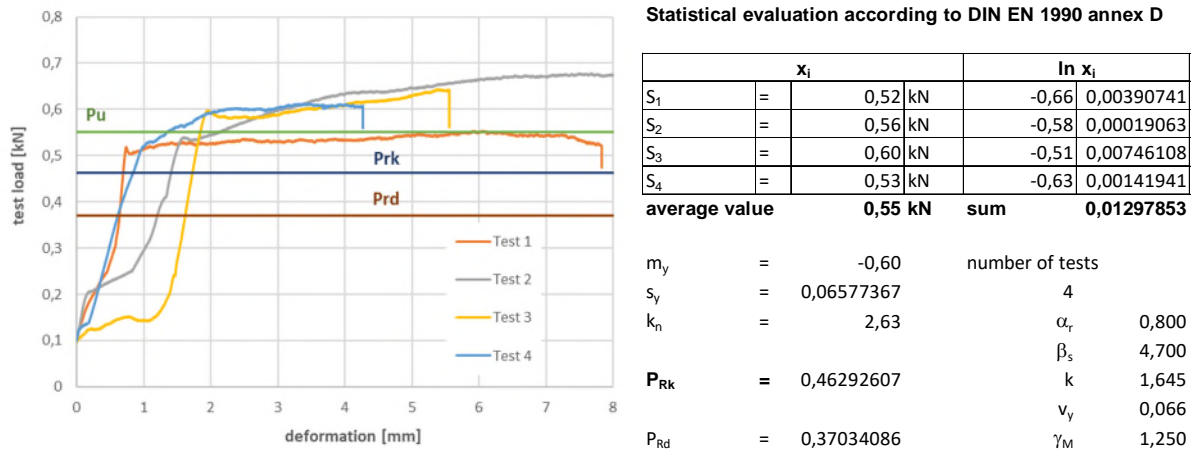
Fig. 4 shows the test records and the results of the statistical evaluation to determine the characteristic load-bearing capacity and the rated value of the load-bearing capacity.

Fig. 4 Test records and statistical evaluation of design values of the shear capacity

The measuring curves show a linear increase of the load deformation curves up to the point where the static friction is exceeded. With further feed the process passes into sliding friction, with only a small load increase being possible. The initial shiftings for the tests 2 and 3 result from settlements of the test setup and are not decisive for the test evaluation. The perceptible excess of static friction was selected as evaluation level. The mean value resulting from the 5 tests is $P_u = 0,55$ kN. Based on a statistical evaluation, the characteristic value of the load bearing capacity $P_{Rk} = 0,46$ kN was determined. This value represents the 5% fractile. For the verification of the structural safety, a partial safety factor on the resistance side $\gamma_M = 1,25$ must be considered. The rated value for the shear strength is derived from the following equation:

$$V_{Rd} = V_{Rk} / \gamma_M = 0,46 / 1,25 = 0,37 \text{ kN}$$

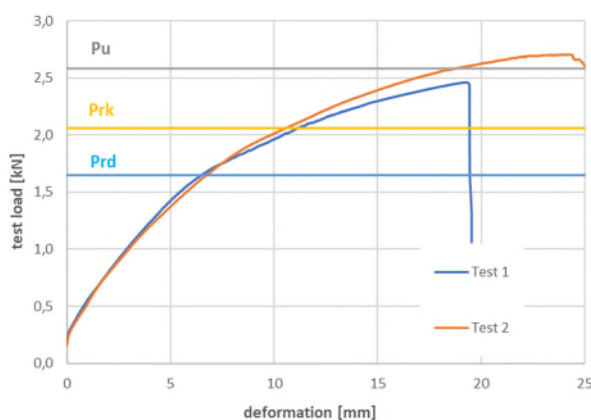
Statistical evaluation according to DIN EN 1990 annex D

x_i	$\ln x_i$	
S_1	=	2,46 kN	0,90	0,00222393
S_2	=	2,70 kN	0,99	0,00222393
average value		2,58 kN	sum	0,00444786
m_y	=	0,95	number of tests	
S_y	=	0,06669226	2	
k_n	=	3,37	α_r	0,800
			β_s	4,700
P_{Rk}	=	2,06057695	k	1,645
			v_y	0,067
P_{Rd}	=	1,64846156	γ_M	1,250

Fig. 6 Test records and statistical evaluation of design values of the tensile capacity

The average ultimate load was $P_u = 2,58$ kN. The statistical evaluation with a fractile factor $k_n = 3,37$, which takes into account the small number of tests, provides a characteristic value for the tensile strength $F_{t,Rk} = 1,27$ kN. With the partial safety factor $\gamma_M = 1,25$ the rated value for the tensile strength is:

$$V_{Rd} = V_{Rk} / \gamma_M = 2,06 / 1,25 = 1,65 \text{ kN}$$

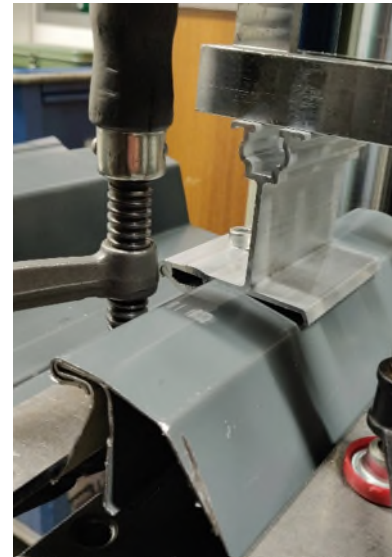
Fig. 6 Test record of the pressure test

Only a single test was carried out as a reference for the compressive strength, as pressure forces are typically not decisive for the verification of the seam clamp. The measuring record shows that the seam only fails at a load of This load level in pressure direction only represents the load bearing capacity of the clamp itself. Usually, the load capacity of the roof is on a much lower level. Thus, the rated value of the load bearing capacity in pressure direction can be limited to $F_{p,Rd} = 1,5$ kN on the safe side.
