Test documentation 2020-109

Experimental examination on the
load bearing capacity of a seam clamp
for the roof covering Diamondek

Customer:

Schletter Solar GmbH
Alustrasse 1

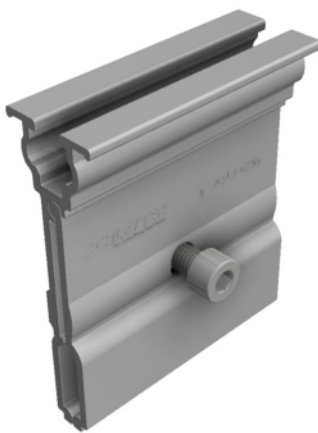
Fig. 2 isometric display of the seam clamp

Fig. 2 shows the seam clamp for the specific geometry of the Diamondek profile. This clamp has two legs, which overlap the chord to realize a complete clamping. Tensile and pressure forces are thus introduced directly into the profile. The limiting factor is the weakness of the chord.

Shear forces parallel to the upper chords of the sheet metal resulting from the slope downforce of the solar generator are transmitted by friction. Thus it is essential that the screw is tightened with a defined torque of 15 Nm.

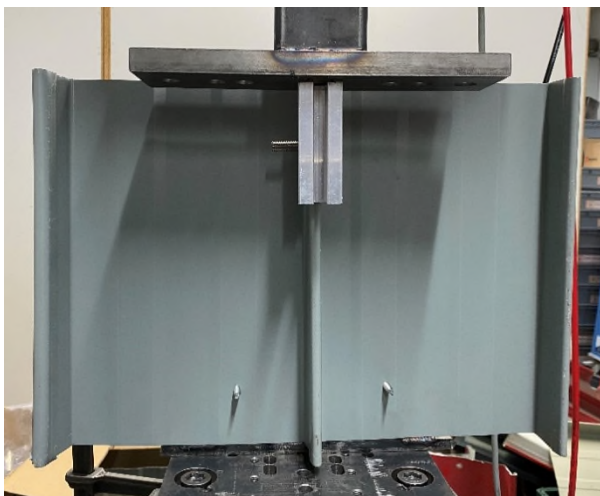
The test set-up for the shear tests is shown in Fig. 3. The clamp was fixed at a roof section with a torque of 15 Nm. In the testing procedure the seam clamp was pushed parallel to the crown directly above the crown to exclude favorable effects from bending.

Figure 3 Test set-up for the shear tests

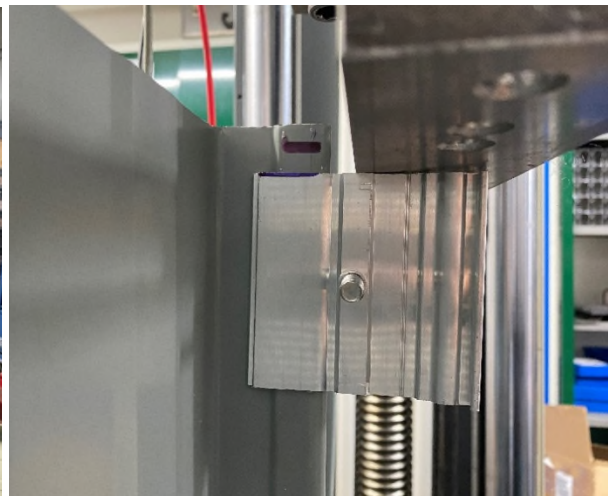
Figure 4 locking effects at the end of the shear tests

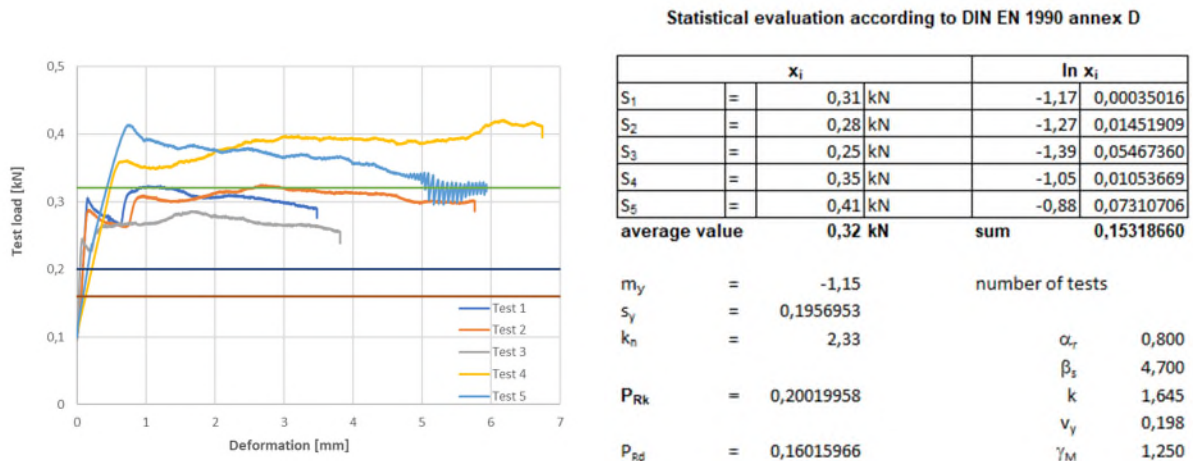
Fig. 5 shows the test records and the results of the statistical evaluation to determine the characteristic load-bearing capacity and the rated value of the load-bearing capacity.

Fig. 5 Test records and statistical evaluation of design values of the shear capacity

The measuring curves show a linear increase of the load deformation curves up to the point where the static friction is exceeded. With further feed the process passes into sliding friction, with only a small load increase being possible. The perceptible excess of static friction was selected as evaluation level. The mean value resulting from the 5 tests is $P_u = 0,32$ kN. Based on a statistical evaluation, the characteristic value of the load bearing capacity $P_{Rk} = 0,20$ was determined. This value represents the 5% fractile. For the verification of the structural safety, a partial safety factor on the resistance side $\gamma_M = 1,25$ must be considered. The design value for the shear strength is derived from the following equation:

$$V_{Rd} = V_{Rk} / \gamma_M = 0,2 / 1,25 = 0,16 \text{ kN}$$

design value the shear strength $V_{Rd} = 0,16$ kN

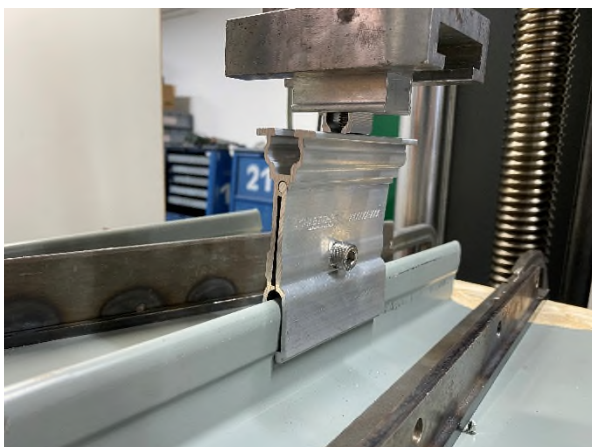
Figure 6 Test set-up for the tension tests

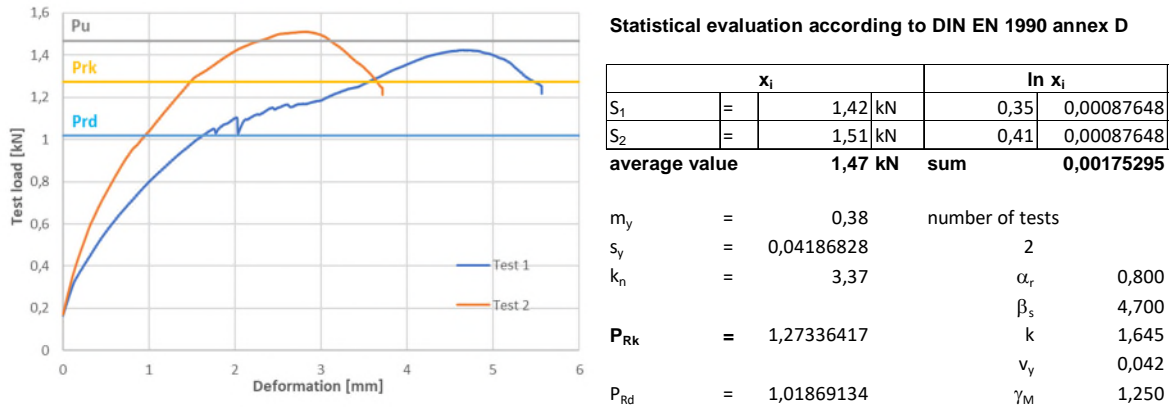
As the tensile strength typically shows significantly less variation than the shear strength, only two tensile tests were carried out to determine the values. Fig. 8 shows the measuring records. The failure was always due to slip of the seam clamp from the chord.

Fig. 8 Test records and statistical evaluation of design values of the shear capacity

The average ultimate load was $P_u = 1,47$ kN. The statistical evaluation with a fractile factor $k_n = 3,37$, which takes into account the small number of tests, provides a characteristic value for the tensile strength $F_{t,Rk} = 1,27$ kN. With the partial safety factor $\gamma_M = 1,25$ the rated value for the tensile strength is:

$$V_{Rd} = V_{Rk} / \gamma_M = 1,27 / 1,25 = 1,02 \text{ kN}$$

design value of tensile strength $F_{t,Rd} = 1,00$ kN

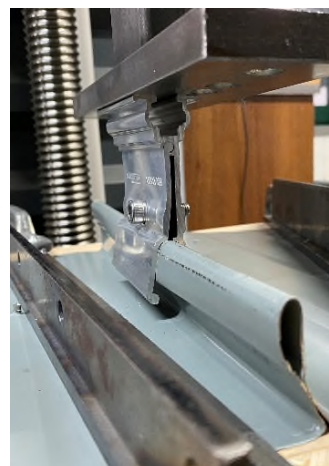
Fig. 9 Test record of the pressure test

Only a single test was carried out as a reference for the compressive strength, as pressure forces are typically not decisive for the verification of the seam clamp. The measuring record shows that the seam fails at a load of 5,8 kN. This load level in pressure direction only represents the load bearing capacity of the clamp itself. Usually the load capacity of the roof is on a much lower level. Thus, the design value of the load bearing capacity in pressure direction can be limited to $F_{p,Rd} = 2,5$ kN on the safe side.

design value of compressive strength $F_{p,Rd} = 2,50$ kN
