专案名称:	Axpert VM III-5000/VM III-3000				
专案编号:	S1711171	修订版次:	00	PAGE	1 / 3

# 维修手册

**Axpert VM III-5000/ VM III-3000  
Service manual**

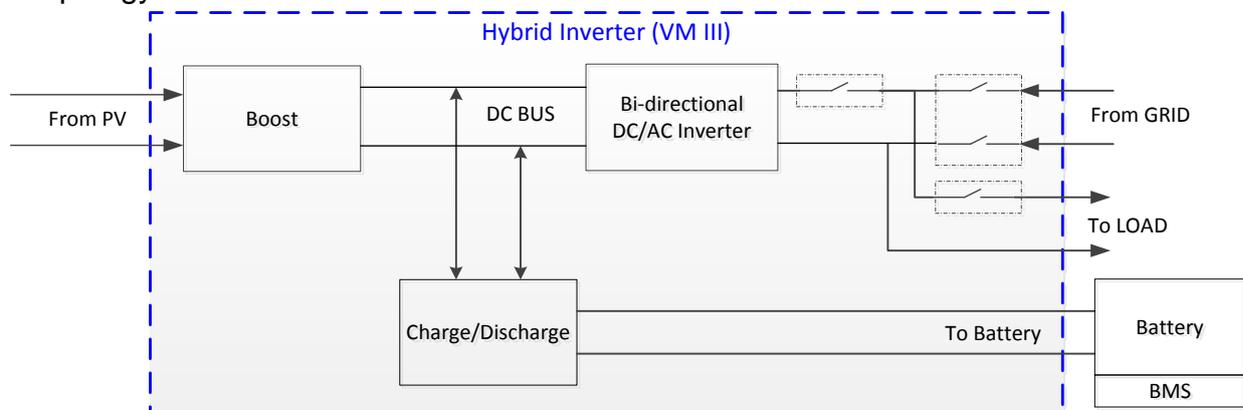
The topology of the inverter shows as below:

Compare with UPS or normal inverter, INVERTER combines a solar charger inside. Solar charger can be a supplement for battery when there is not grid. And with the solar charger, the inverter can have more working modes than UPS. For detail information please refer to our user manual.

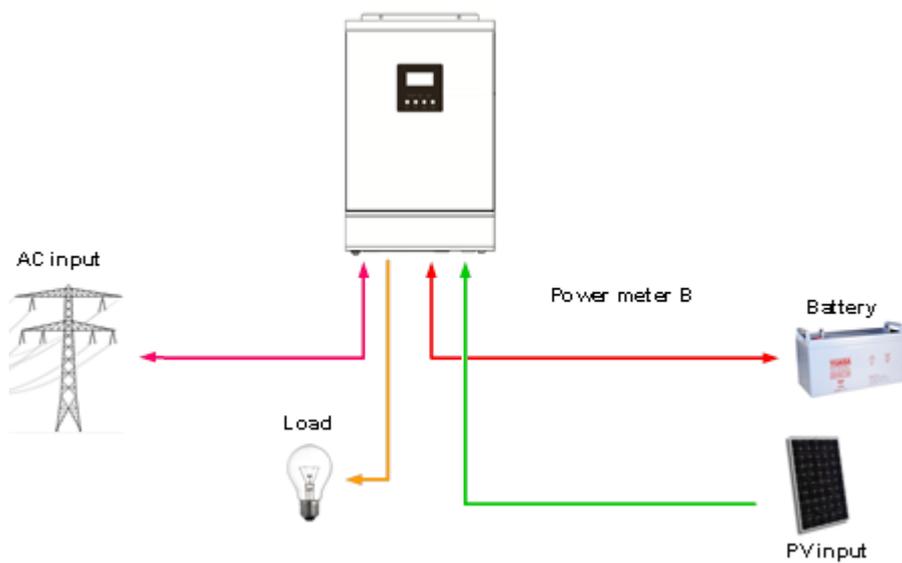
Set up the testing system as below:

After replacing all defected components, testing steps can be used to confirm the repair result and the reliability of the Inverter.

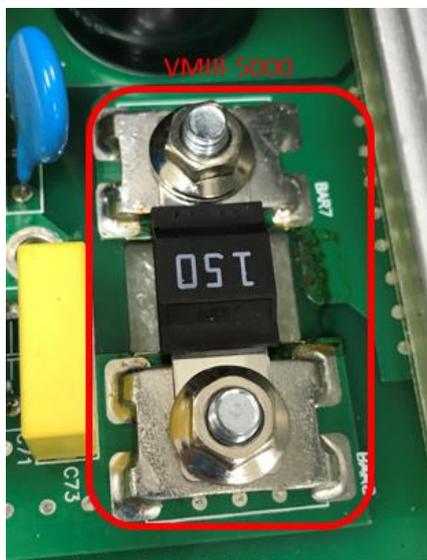
For VMIII-3000 FUCE 150A

For VMIII-5000 FUCE 150A

Parts	Attribute	Reference values	Failure status
F5	Resistor	0.1 ohm	Open

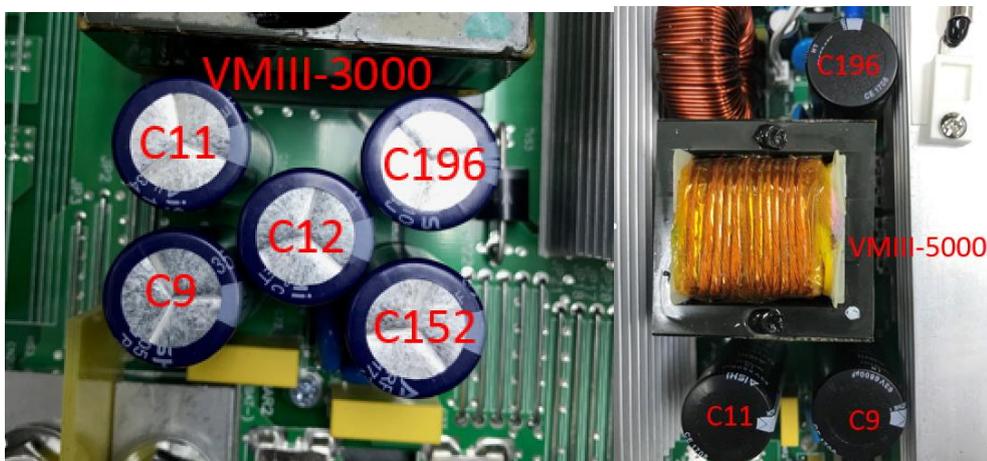
For VMIII-3000 C9/C11/C12/C196/C152: (4200uF 35V)

For VMIII-5000 C9/C18/C196: (6800uF 63V)

If the capacitors explode as below, they need to be replaced.

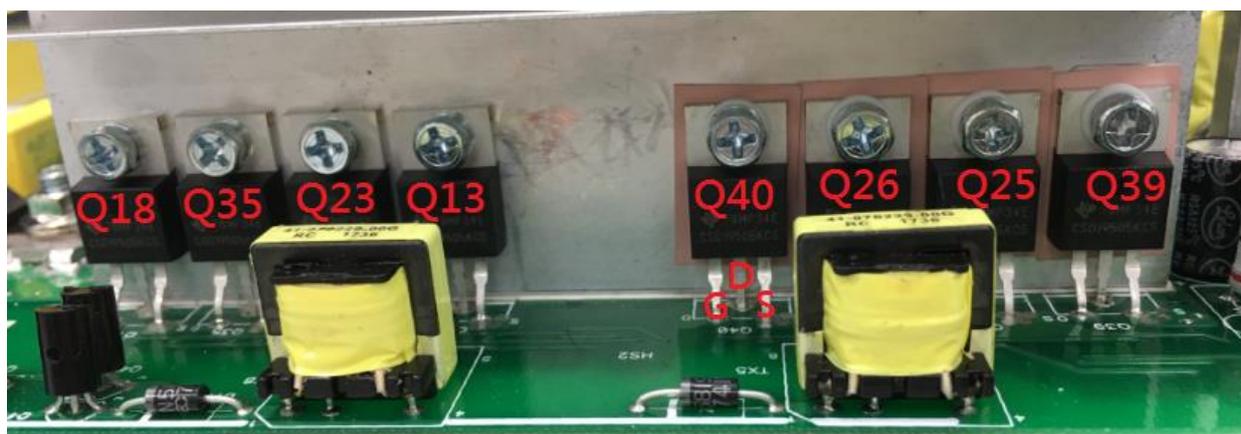
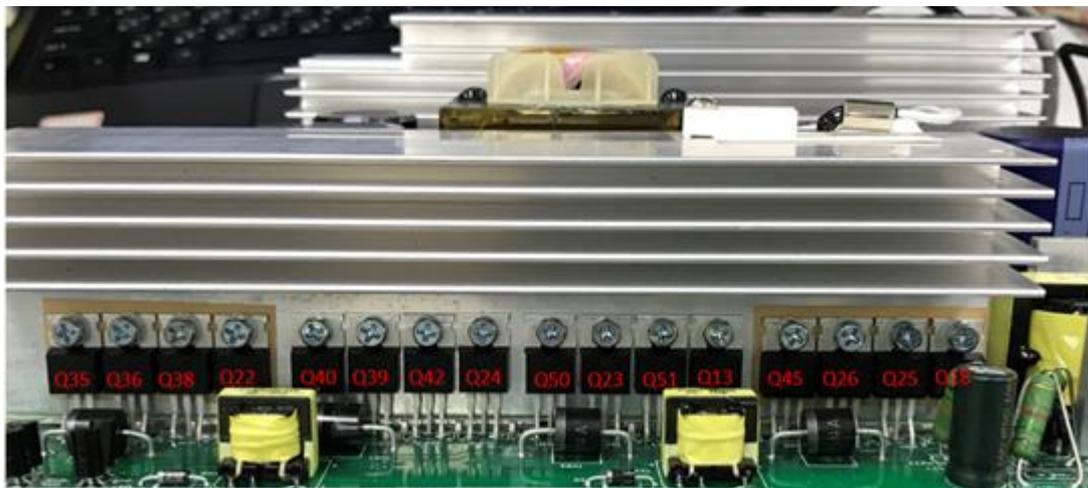
DC/DC MOSFET: Q13/Q18/Q23/Q35 & Q25/Q26/Q39/Q40

For VMIII-3000 ALL of the MOSFET are (CSD19505KCS 201A 80V TO-220)

For VMIII-5000 ALL of the MOSFET are (MOSFET TOSHIBA/TK100E08N1 214A 80V N BULK TO-220)

Parts	Attribute	Reference values	Failure status
CSD19505KCS (VMIII-3200)	Resistor	GS: 11.75k	Short or explosion
TK100E08N1 (VMIII-5200)		GD: 115.8k DS: OL	
	Diode	SD: 0.463V DS: OL

**Note1:** When you use the multimeter to measure the resistor of the transistor, because of the capacitor in the circuit, it will cause the changing of the values when you measure the DS and GD. So we recommend you measure the diode forward voltage of SD, and the resistor of GS. These two values can reflect the situation of the transistor more correctly.

**Note2:** If one or more of them were damaged, please replace all of them.

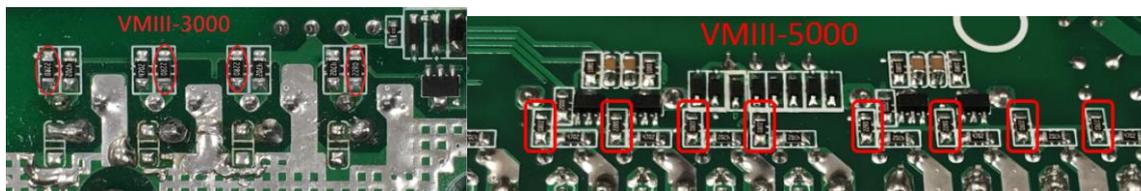
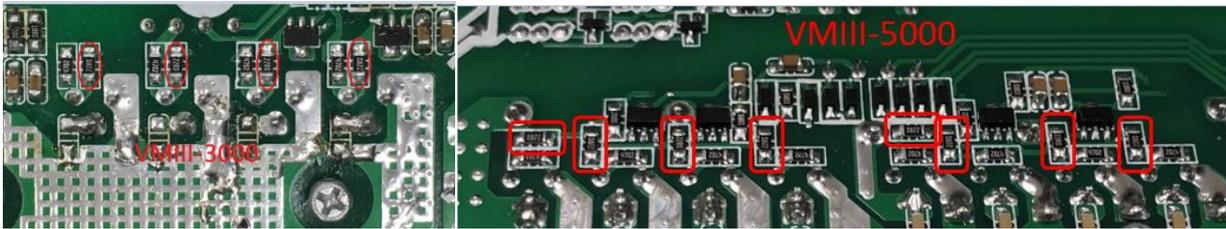
R52/R62/R81/R87/R92/R93/R115/R119 All of the resistors are (22R 1206)

Use multimeter to measure each resistor, find the burnt resistors and replace them; don't need to replace them all.

Parts	Attribute	Reference values	Failure status
All: 22ohm	Resistor	22 ohm	Open or other values

If the resistors need to be replaced, please also check the driver transistors and control IC.

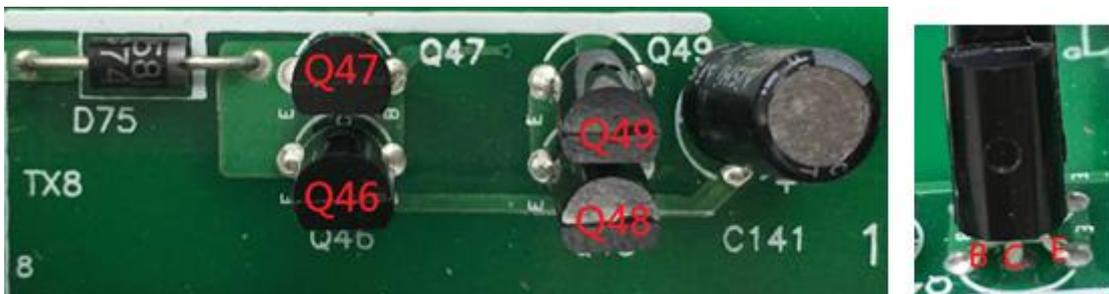
The Q46 and Q48 are (2SC2655 2A 50V NPN TAP TO-92)

The Q47 and Q49 are (2SA1020L-Y-T9N-B 2A 50V PNP TAP TO-92NL)

Parts	Attribute	Reference values	Failure status
Q46/Q48	Resistor	BE: 430k BC: 430k	Short or explosion

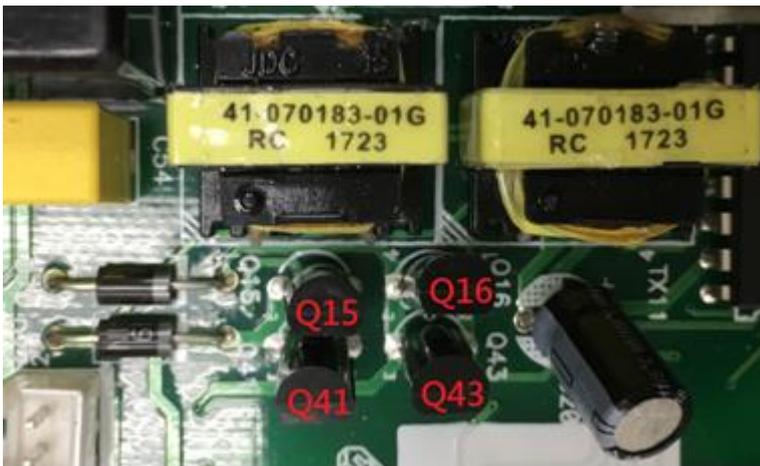
The Q41 and Q43 are (2SC2655 2A 50V NPN TAP TO-92)

The Q15 and Q16 are (2SA1020L-Y-T9N-B 2A 50V PNP TAP TO-92NL)

EC: 16k	
	Diode	BE: 0.65V BC: 0.65V CE: 0.28V	
Q41/Q43	Resistor	BE: 430k BC: 425k EC: 104k	Short or explosion
	Diode	BE: 0.65V BC: 0.65V CE: 0.28V	
Q47/Q49	Resistor	BE: 430k BC: 430k EC: 8k	Short or explosion
	Diode	BE: 0.65V BC: 1.75V CE: 0.20V	
Q15/Q16	Resistor	BE: 430k BC: 430k CE: 8k	Short or explosion
	Diode	BE: 0.65V BC: 1.5V CE: 0.28V

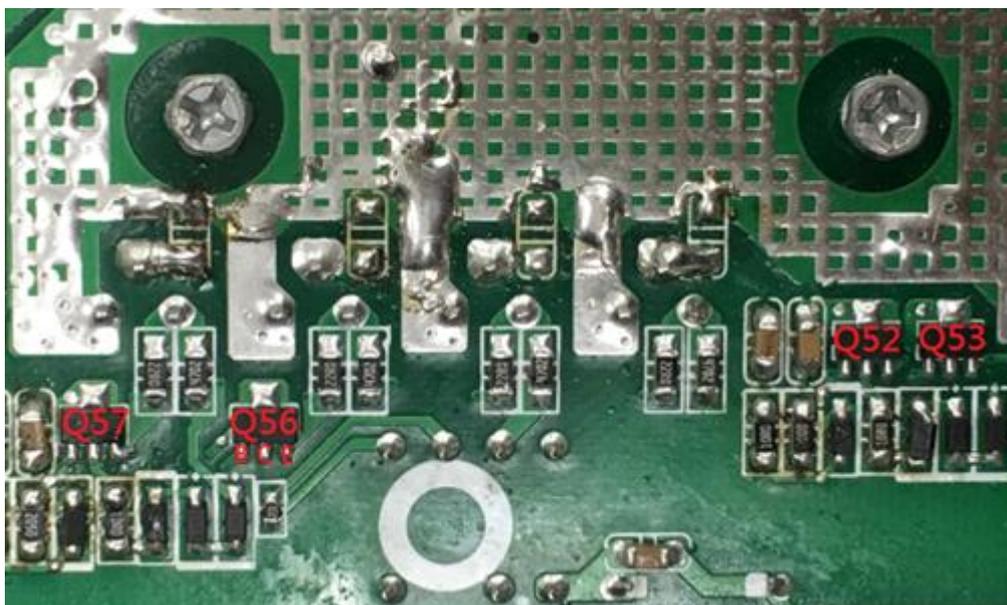
The Q52 and Q56 are (2SD1624 2A 50V NPN SOT-89)

The Q53 and Q57 are (2SA1020 3A 50V PNP SOT-89)

Parts	Attribute	Reference values	Failure status
Q52/Q56	Resistor	BE: 12k BC: 280k CE: OL	Short or explosion
	Diode	BE: 0.64V BC: 0.64V CE: OL	
Q53/Q57	Resistor	BE: 12k BC: OL CE: 280k	Short or explosion
	Diode	BE: 0.64V BC: OL CE: 1.09V

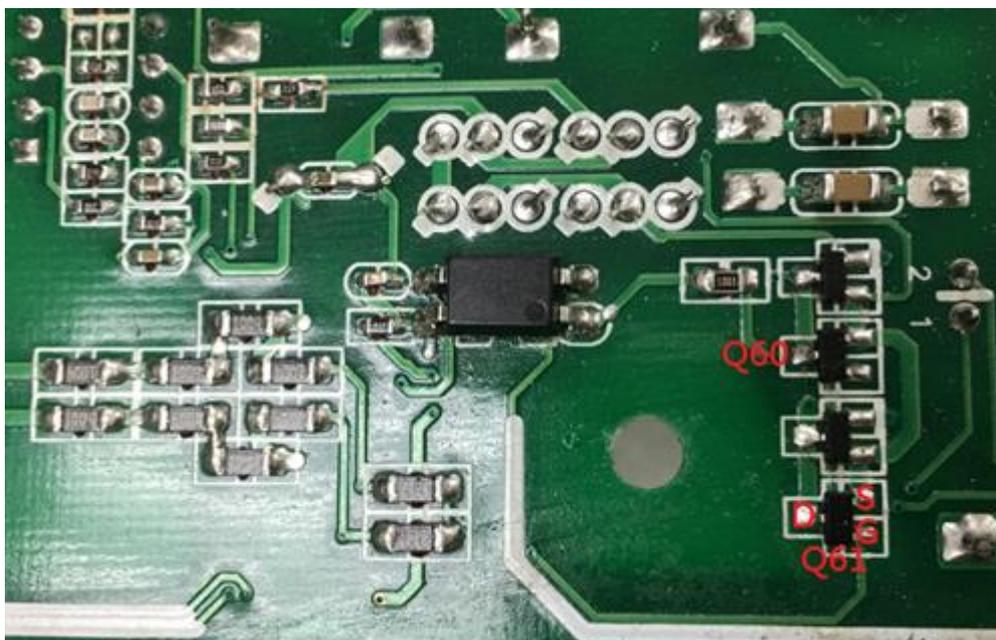
The Q60 and Q61 the MOSFET are (UT3404G 5.8A 30V NPN SOT-23 SMD)

Parts	Attribute	Reference values	Failure status
Q60/Q61	Resistor	GS: 5.637k GD: 107k SD: 98k	Short or explosion
	Diode	SD: 0.28V DS: 1.14V

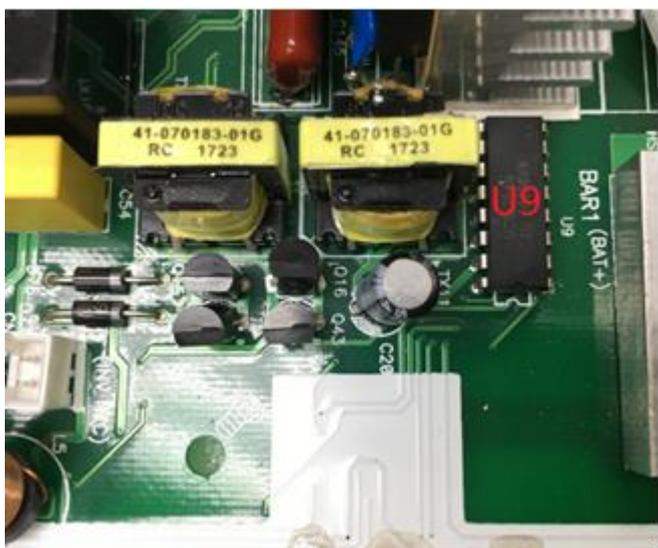
The U9 is (IC PWM CNTL TI/UC3525AN DIP-16)

Parts	Attribute	Reference values	Failure status
U9	Resistor	PIN13 TO PIN12: 8.8k PIN11 TO PIN12: 432k PIN14 TO PIN12: 432k	Short or explosion

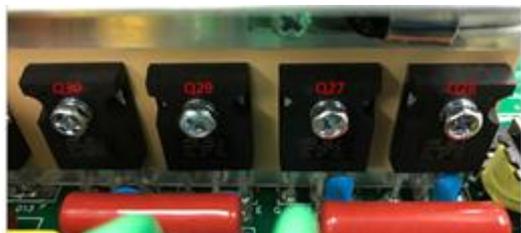
DC/DC IGBT: Q27/Q28/Q29/Q30

For VMIII-5000 ALL of the IGBTs are (IGBT ST/STGW60H65DFB 60A 650V N BULK TO-247)

For VMIII-3000 ALL of the IGBTs are (STGW45HF60WDA 45A 600V NPN BULK TO-247)

Parts (VMIII-3200)	Attribute	Reference values	Failure status
Q27/Q28/Q29/Q30	Resistor	GE: 22 ohm GC: 184k EC: 184K	Short or explosion
	Diode	EC: 0.37V CE: OL	
Parts (VMIII-5200)	Attribute	Reference values	Failure status
Q27/Q28/Q29/Q30	Resistor	GE: 22 ohm GC: 205k EC: 205K	Short or explosion
	Diode	EC: 0.39V CE: OL

**Note1:** When you use the multimeter to measure the resistor of the transistor, because of the capacitor in the circuit, it will cause the changing of the values when you measure the CE and GE. So we recommend you measure the diode forward voltage of EC, and the resistor of GE. These two values can reflect the situation of the transistor more correctly.

**Note2:** If one or more of them were damaged, please replace all of them.

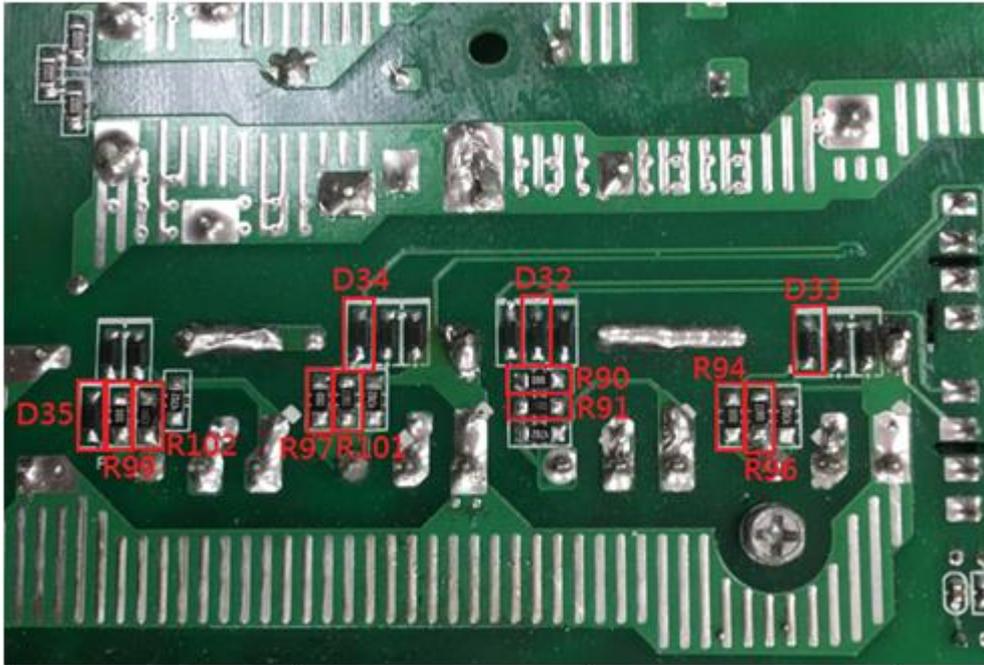
R91/R102/R96/R101: (22R 1206)

R90/R99/R94/R97: (0R 1206)

D32/D35/D33/D34: (1N4148W 0.15A 75V SMD)

Parts	Attribute	Reference values	Failure status
R91/R102/R96/R101	Resistor	22 ohm	Open or other values
R90/R99/R94/R97	Resistor	0 ohm	
D32/D35/D33/D34 <sup>1</sup>	Resistor	+ to -: 270k - to +: OL	Short or explosion
	Diode	+ to -: 0.6V - to +: OL

**Note1:** When test the diode; please remove the R90/R99/R94/R97 from the board, or the test result is not right.

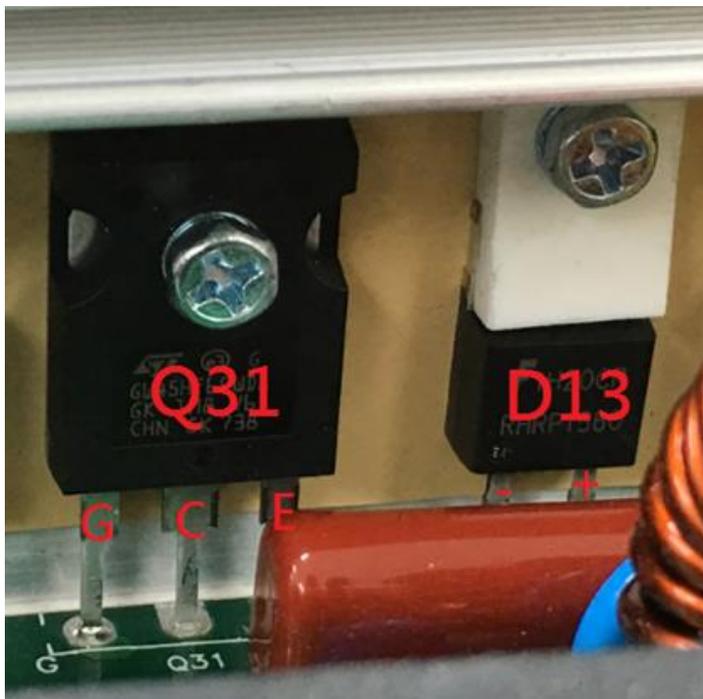
BUCK MOSFET and Diode: Q31/D13

For VMIII-5000 the IGBTs Q31 is (IGBT ST/STGW60H65DFB 60A 650V N BULK TO-247)

For VMIII-3000 the IGBTs Q31 is (STGW45HF60WDA 45A 600V NPN BULK TO-247)

The D13 is (RHRP1560 15A 600V UFST RAD BULK)

Parts	Attribute	Reference values	Failure status
Q31	Resistor	GE: 22.8k GC: 49.5k CE: OL	Short or explosion
	Diode	CE: OL EC: 0.393V	
D13	Resistor	+ to -: 195k - to +: OL/OL	
	Diode	+ to -: 0.39V - to +: OL

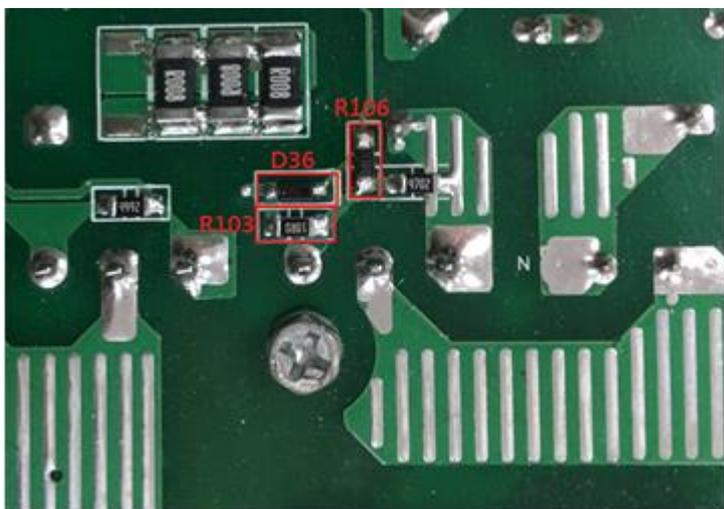
The R103 are (10R 1206)

The R106 are (47R 1206)

The D36 are (1N4148W 0.15A 75V SMD)

Parts	Attribute	Reference values	Failure status
R106	Resistor	47 ohm	Open or other values
R103	Resistor	10 ohm	
D36 <sup>1</sup>	Resistor	+ to -: 240k - to +: OL	Short or explosion
	Diode	+ to -: 0.6V - to +: OL

**Note1:** When test the diode; please remove the R103 from the board, otherwise the test result is not right.

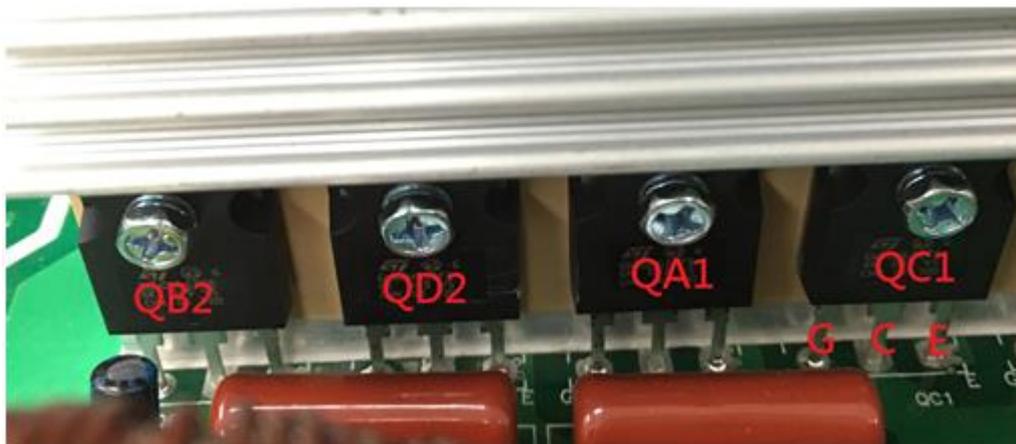
INV IGBT: QA1/QC1/QB2/QD2

All of the IGBT are (STGW60H65DFB 60A 650V N BULK TO-247)

Parts	Attribute	Reference values	Failure status
QA1/QC1/QB2/QD2	Resistor	GE: 23k GC: 235k CE: 700k	Short or explosion
	Diode	EC: 0.4V CE: OL

Note1: If one or more of them were damaged, please replace all of them.

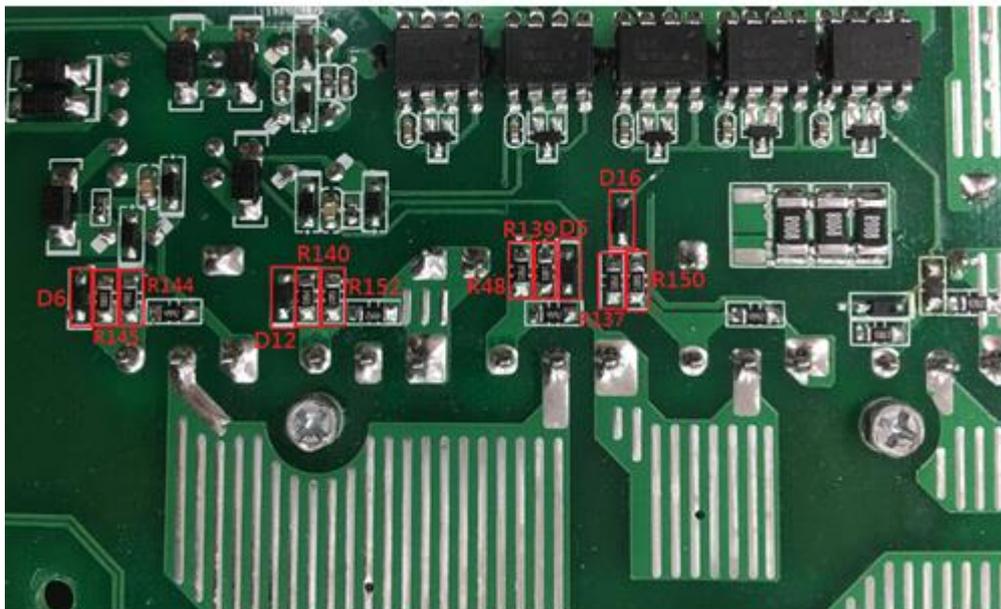
R48/R144/R140/R137: (39R 1206)

R139/R145/R150/R152: (10R 1206)

D5/D6/D12/D16: (1N4148W 0.15A 75V SMD)

Parts	Attribute	Reference values	Failure status
R48/R144/R140/R137	Resistor	39 ohm	Open or other values
R139/R145/R150/R152	Resistor	10 ohm	Open or other values
D5/D6/D12/D16 <sup>1</sup>	Resistor	+ to -: 270k - to +: OL	Short or explosion
	Diode	+ to -: 0.6V - to +: OL

**Note1:** When test the diode; please remove the R139/R145/R150/R152 from the board, ortherwise the test result is not right

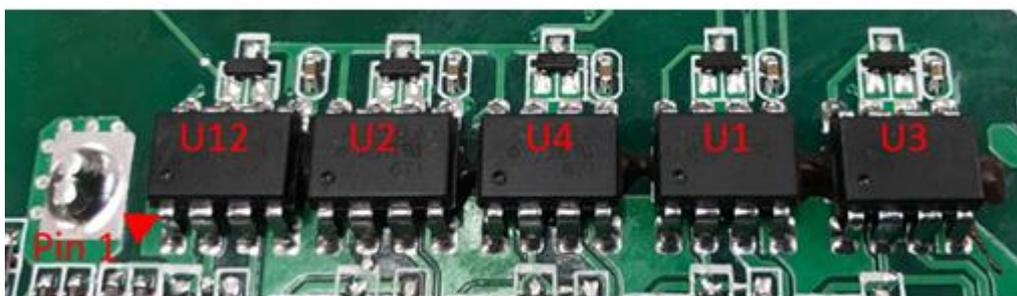
Optocoupler: U1/U2/U3/U4/U12

ALL of the optocoupler are (AVAGO/T350-560E DIP-8 8/300 MIL SMD)

Parts	Attribute	Reference values	Failure status
U2/U4/U12	Resistor	PIN8 TO PIN5: 57k PIN7 TO PIN5: 145k	Short or explosion
U1/U3	Resistor	PIN8 TO PIN5: 355k PIN7 TO PIN5: 410k

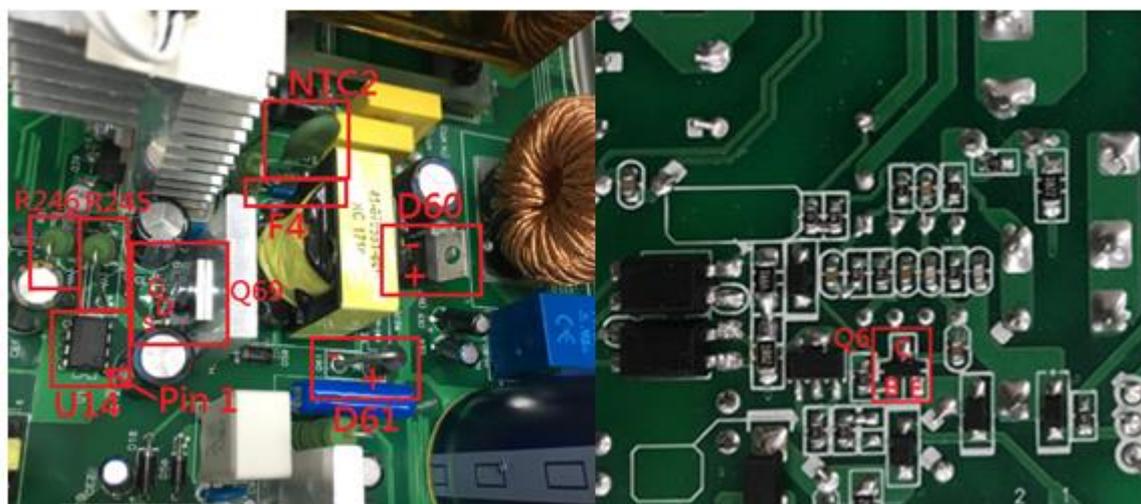
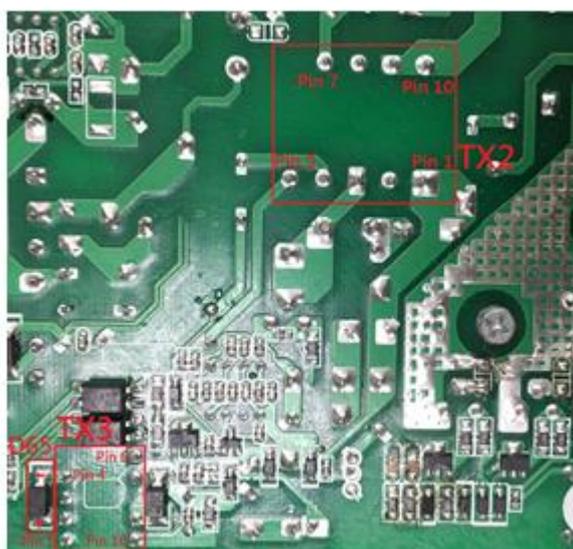
### BATT Power SPS

For VMIII-5000 the F1 are (FUSE 3A 125V)

For VMIII-5000 the MOSFET Q69 are (MOSFET IR/IRF740 10A 400V N BULK TO-220)

The TX2 are (TX 2:5:45:3 FER EC28)

Parts	Attribute	Reference values	Failure status
F4	Resistor	0 ohm	Open or explosion
NTC2	Resistor	5 ohm	Open or explosion
D61	Diode	+ to -: 0.468V - to +: OL	Short or explosion
D60	Diode	+ to -: 0.435V - to +:OL	Short or explosion
R245	Resistor	0.65ohm	Open or other values
VMIII-3000 R246 VMIII-5000 R245	Resistor	0.65ohm NC	Open or mother values
Q69 <sup>1</sup>	Resistor	GS: 45.51k GD: 57k(VMIII-5000) GD: 44.6k(VMIII-3000) SD: 528K(VMIII-5000) SD: 115K(VMIII-3000)	Short or explosion
	Diode	SD: 0.463V GS: OL	
U14	Resistor	PIN7 TO PIN5: 77.5K PIN6 TO PIN5: 45.48K	Short or other values
Q6	Resistor	EB: 512k	Short or other values

CB: 456k	
	Diode	CB: 0.688V EB: 0.691V	
VMIII-5K TX2	Resistor	PIN7 to PIN9: 0.57 ohm	Short or other values
VMIII-3K TX2	Resistor	PIN7 to PIN9: 0.4ohm	Short or other values
TX3	Resistor	PIN9 to PIN10: 0.3ohm	Short or other values
D65 <sup>2</sup>	Diode	+ to -: 0.52V - to +: OL	Short or explosion

**Note1:** When test the Q69; please remove the R245 from the board, otherwise the test result is not right

**Note2:** When test the D69; please remove the D65 from the board, otherwise the test result is not right

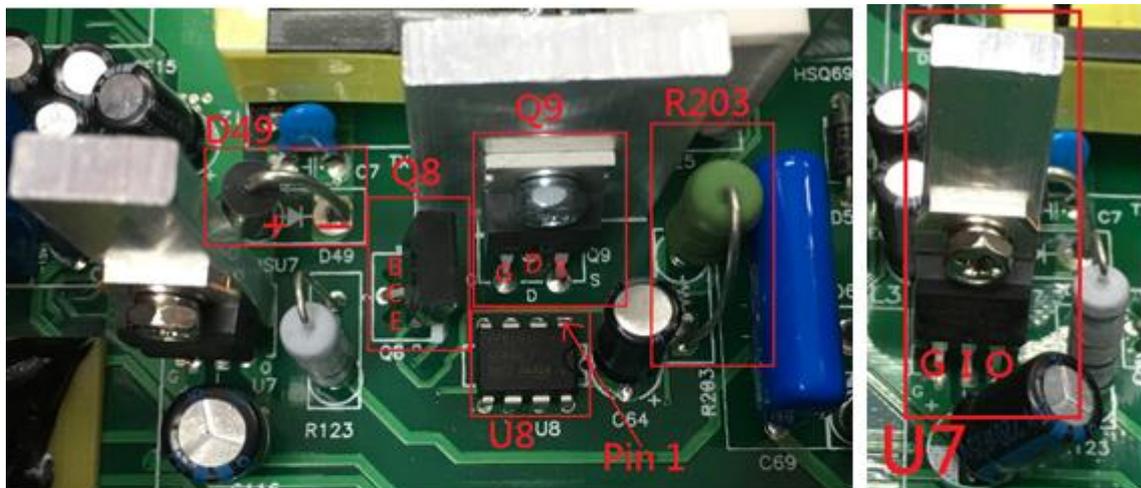
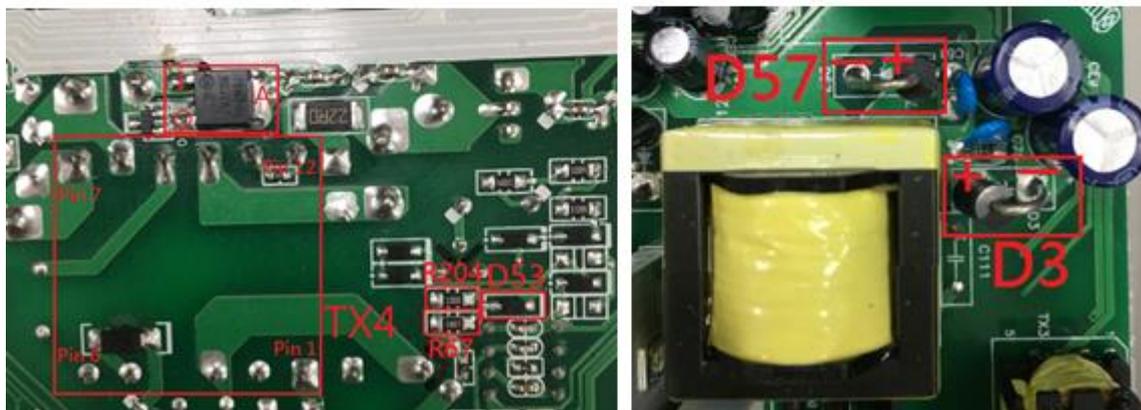
**Main Power SPS**

The MOSFET Q9 are (IXFP7N100P 7A 1000V N BULK TO-220)

The TX4 are (TX 8:21:2:4:8:21:7 FER EC28)

Parts	Attribute	Reference values	Failure status
Q9	Resistor	GS: 45k SD: 300K	Short or explosion
	Diode	SD: 0.52V SG: 0.73V	
Q8	Resistor	BC: 356k BE: 413k	Short or explosion
	Diode	BC: 0.59V BE: 0.61V	
U8	Diode	PIN5 TO PIN7: 0.48V PIN5 TO PIN6: 0.64V	Short or other values
R203	Resistor	0.5 ohm	Open or other values
R204	Resistor	10 ohm	Open or other

values
D53 <sup>1</sup>	Diode	+ to -: 0.52V - to +: OL	Short or explosion
R67	Resistor	10 ohm	Open or other values
D3	Diode	+ to -: 0.4V - to +: 0.7V	Short or explosion
D49/D57	Diode	+ to -: 0.45V - to +: OL	Short or explosion
U7	Diode	PINI to PINO: 0.56V PINO to PING: 0.44V PINI to PING: 0.45V	Short or explosion
U10	Diode	PINA TO PINI: 0.45V PINA TO PINO: 0.5V	Short or explosion
TX4	Resistor	PIN1 TO PIN3: 0.4 ohm	Short or other values

**Note1:** When test the D53; please remove the R67 from the board, otherwise the test result is not right

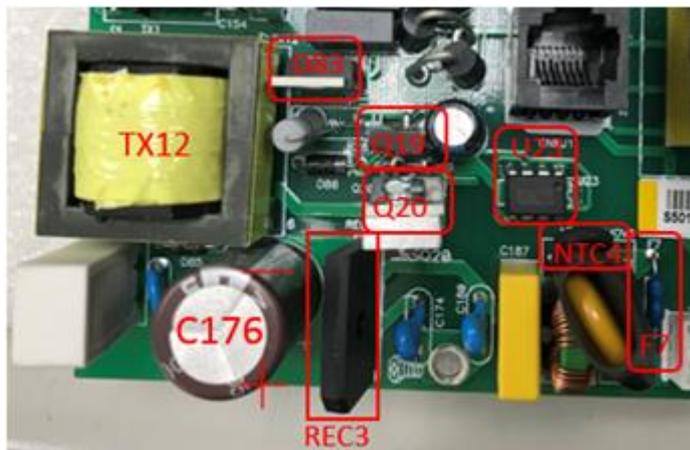
2.6 Check AC SPS

The F7 are (FUSE 3A 125V)

The TX12 are (TX 26:4:42:27 FER EC28)

Parts	Attribute	Reference values	Failure status
F7	Resistor	0.1 ohm	Open or explosion
NTC4	Resistor	11.4 ohm	
D83	Diode	+ to -: 0.458V - to +:OL	Short or explosion
Q20	Resistor	GS: 45.27k SD: 4.711K	Short or explosion
	Diode	SD: 0.536V SG: OL	Short or other values
Q19	Resistor	BC: 361.9k BE: 411.6k	Short or explosion
	Diode	BC: 0.598V BE: 0.611V	
U23	Diode	PIN5 TO PIN7: 0.492V PIN5 TO PIN6: 0.639V	Short or other values
	Resistor	PIN1 TO PIN3: ohm	Short or other values
C176	Capacitance	33uF/450V

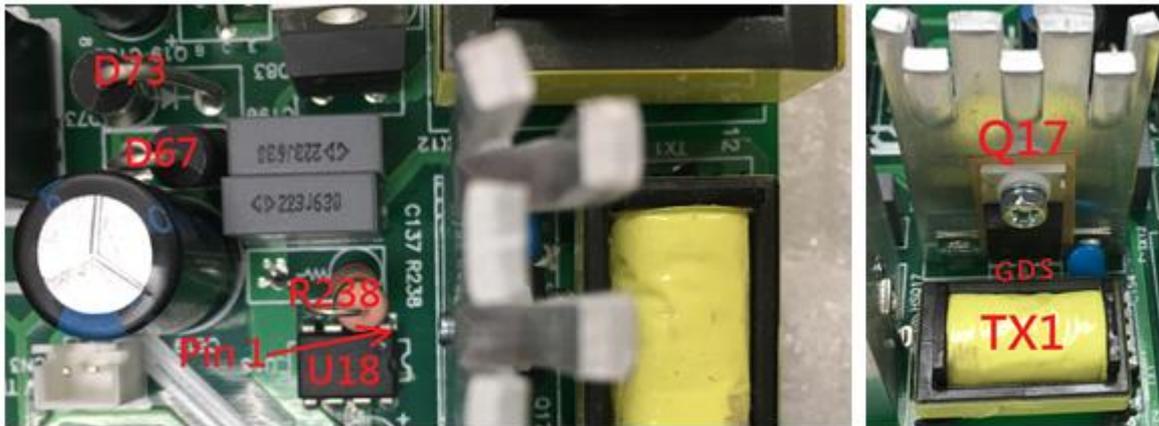
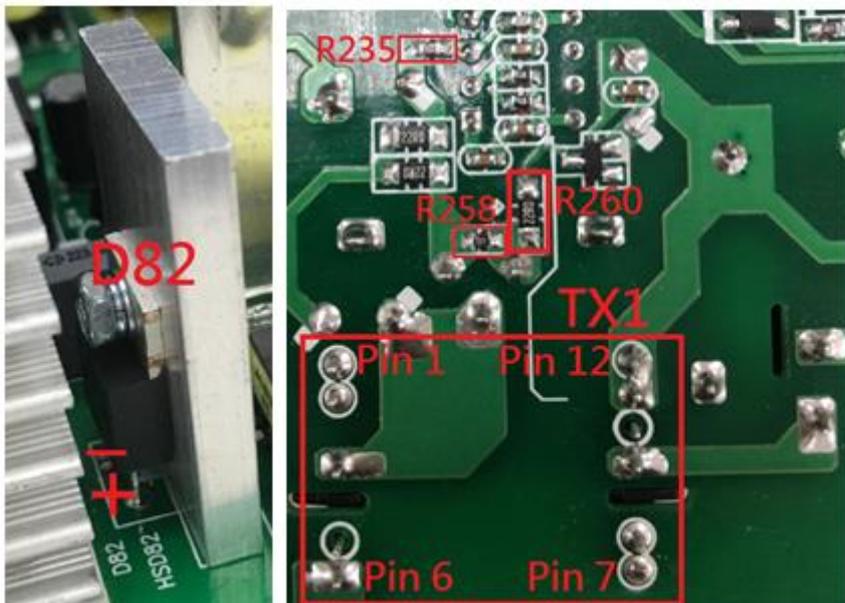
2.7 Check the bus soft start circuit (TX1: Especially for 09 fault)

The D82 are (RHRP8120 8A 1200V UFST)

The TX1 are (TX 55:200:44 FER EEL16)

Parts	Attribute	Reference values	Failure status
D82	Resistor	+ to -: 237k - to +: OL	Short or explosion
	Diode	+ to -: 0.458V - to +: OL

Parts	Attribute	Reference values	Failure status
Q10, Q11	Resistor	GE: 18.29k GC: 206.1k CE: 358.7k	Short or explosion
	Diode	EC: 0.389V CE: OL	
D52	Diode	+ to -: 0.39V - to +: OL

Note: If R260 is damaged, please replace U18 together.

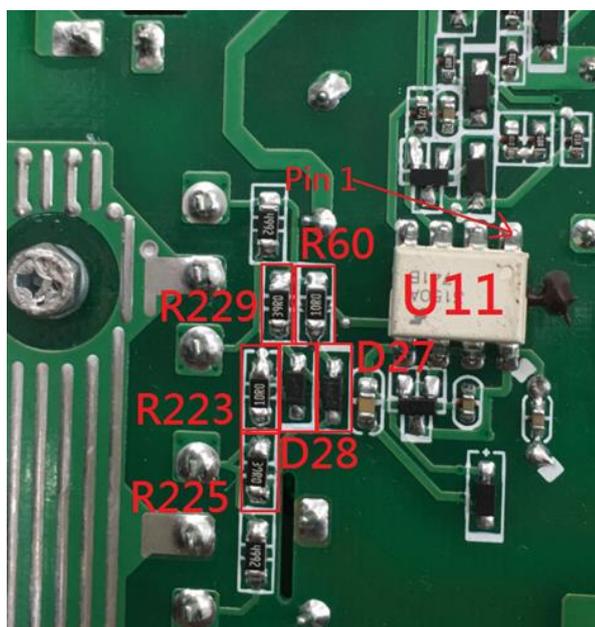
The U11 are (FOD3150ASD SO-8)

The D27 and D28 are (1N4148W 0.15A 75V SMD)

The R60 and R223 are (10R 1206)

The R225 and R229 are (39R 1206)

Parts	Attribute	Reference values	Failure status
U11	Resistor	PIN8 TO PIN5: 350.7k PIN7 TO PIN5: 388k	Short or other values
D27/ D28	Diode	+ to -: 0.6V - to +: OL	Short or explosion

R60/ R223	Resistor	10 ohm	Open or other values
R225/ R229	Resistor	39 ohm	Open or other values

**Note:** When test the diode; please remove the R60/ R223 from the board, or the test result is not right.

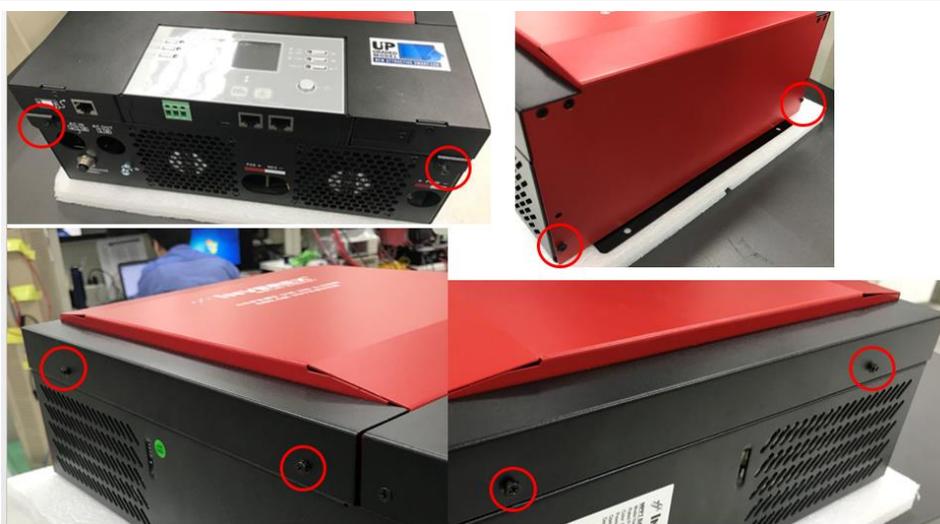
Remove 8 screws on top cover and rear panel.

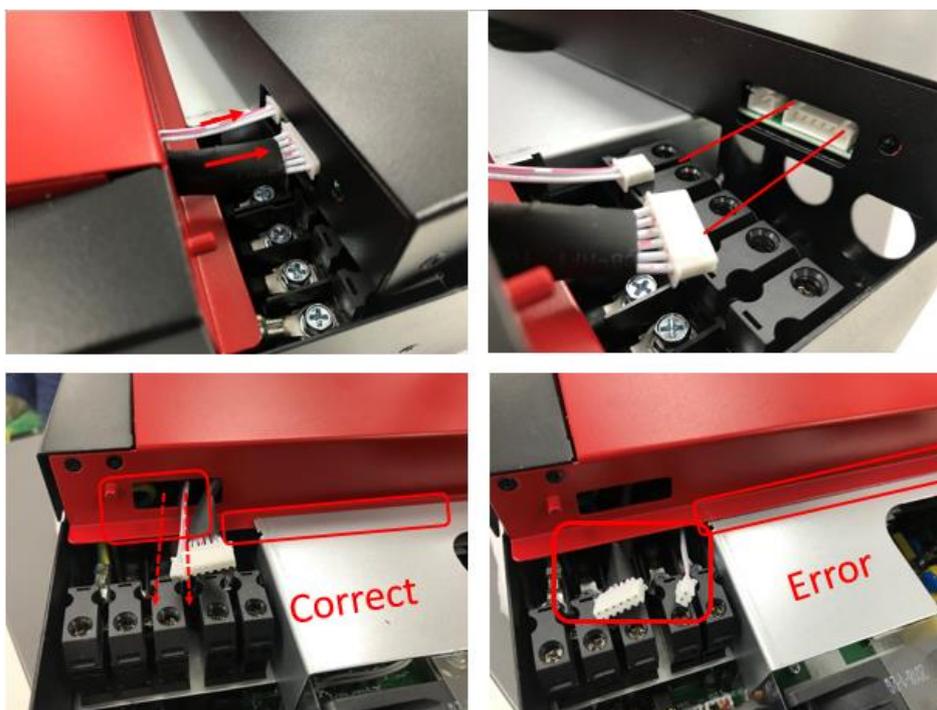
Remove LED cable and LCD cable, and take out the Remote cover.

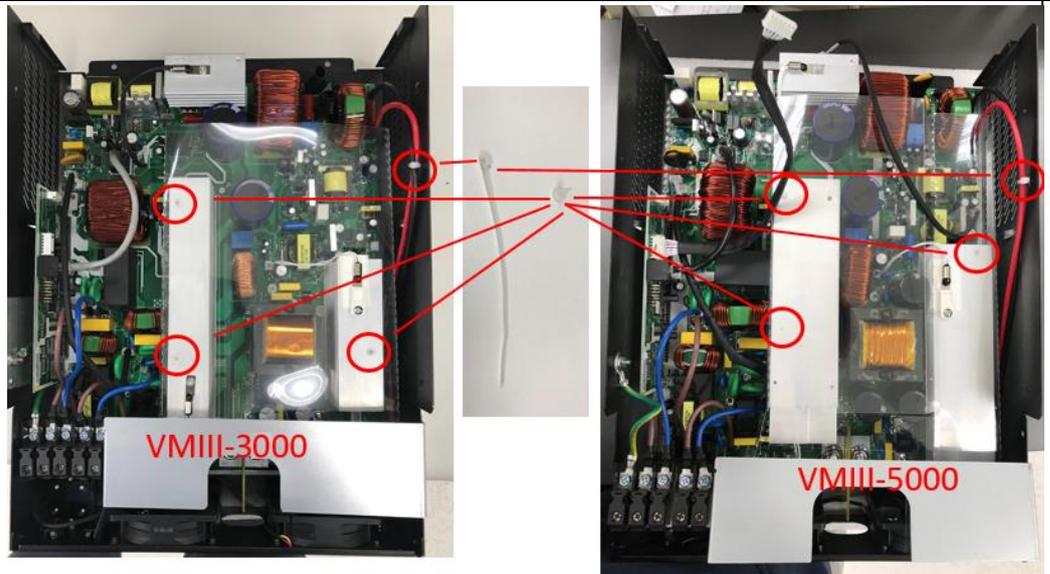
Remove the plastic screws of wind pipeline. Be careful not to damage them. You can use an oblique mouth clamp to help you to remove the clip.

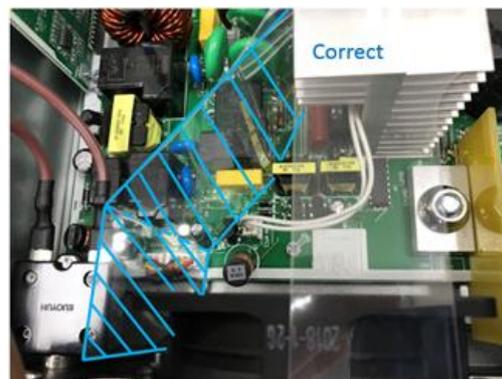
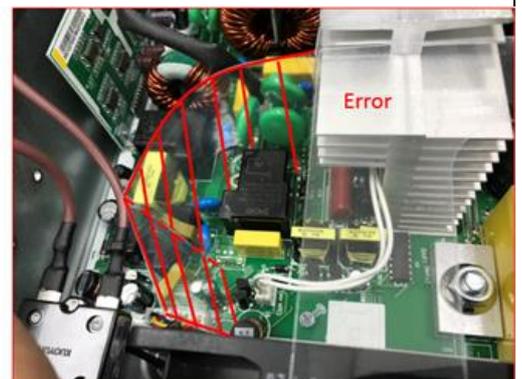
**Please make sure that put the plastic sheet back and fix well. Otherwise it will affect the heat dissipation.**

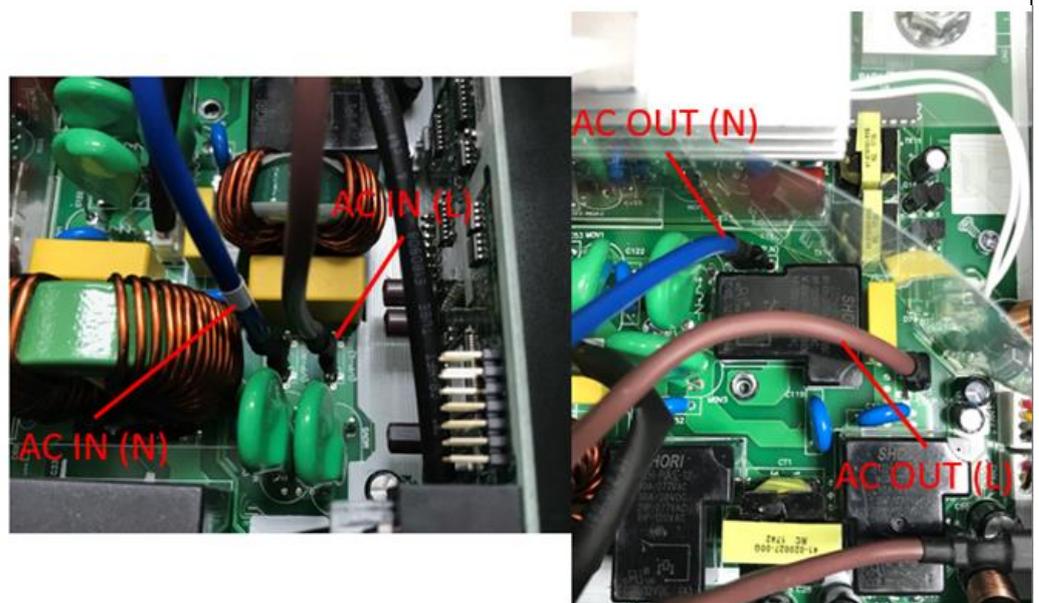
Remove I/P and O/P cables.

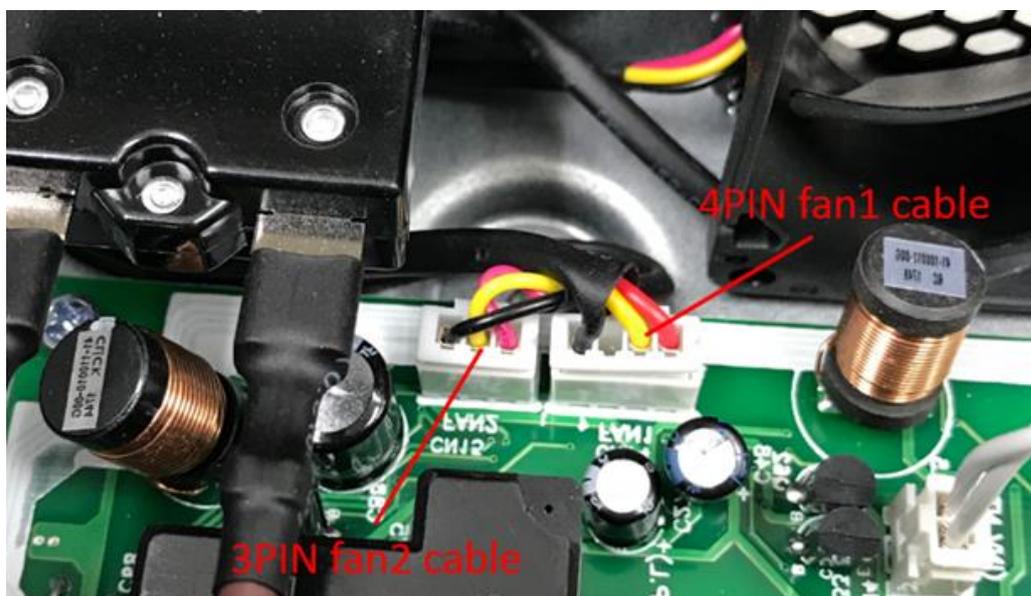
Remove the fan cables.

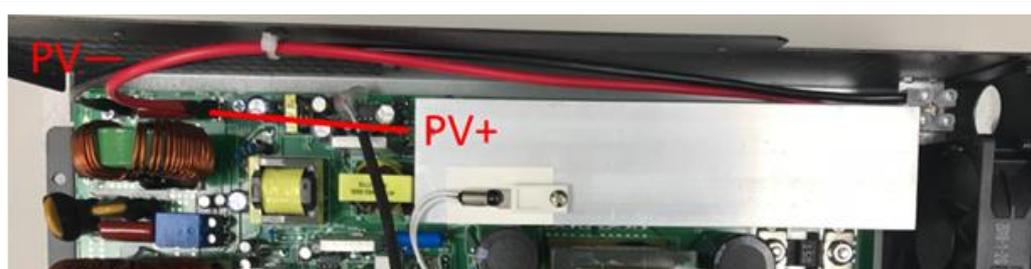
Remove PV IN cable

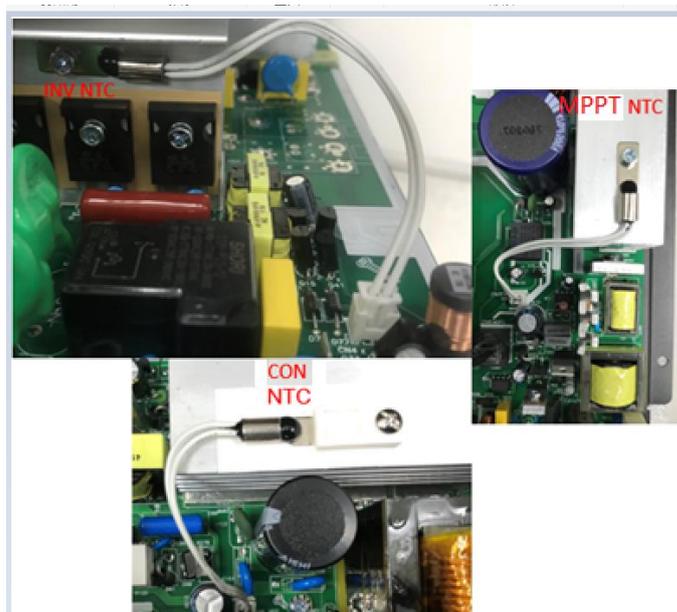
MPPT NTC and Converter NTC and INV NTC

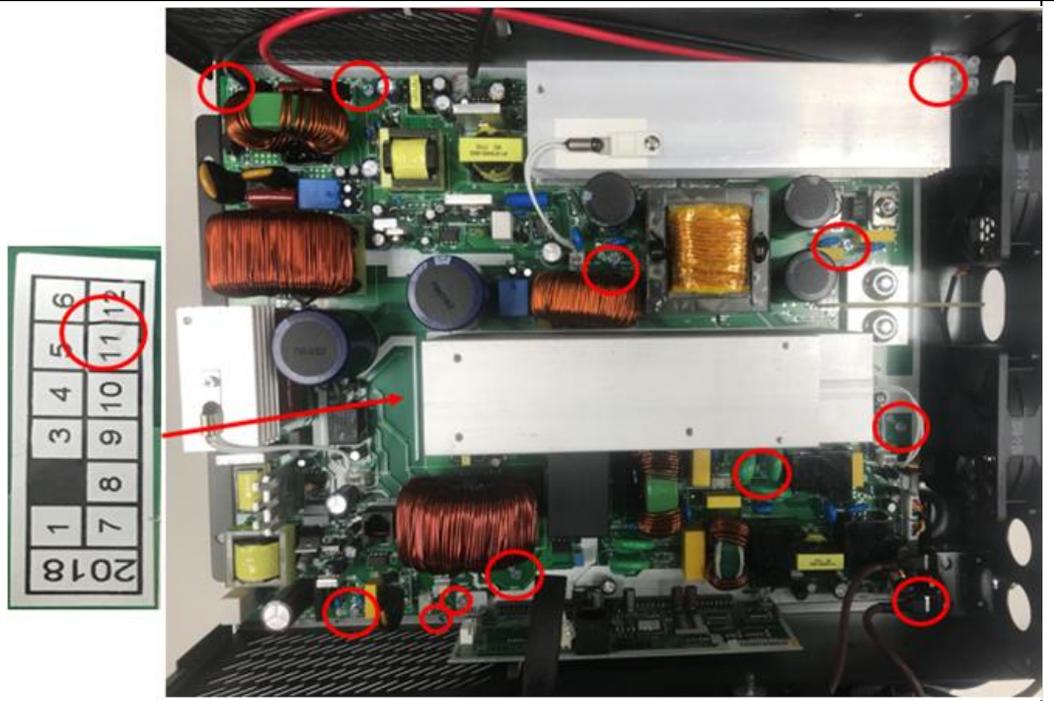
Remove 13 screws on main board and take out the main board

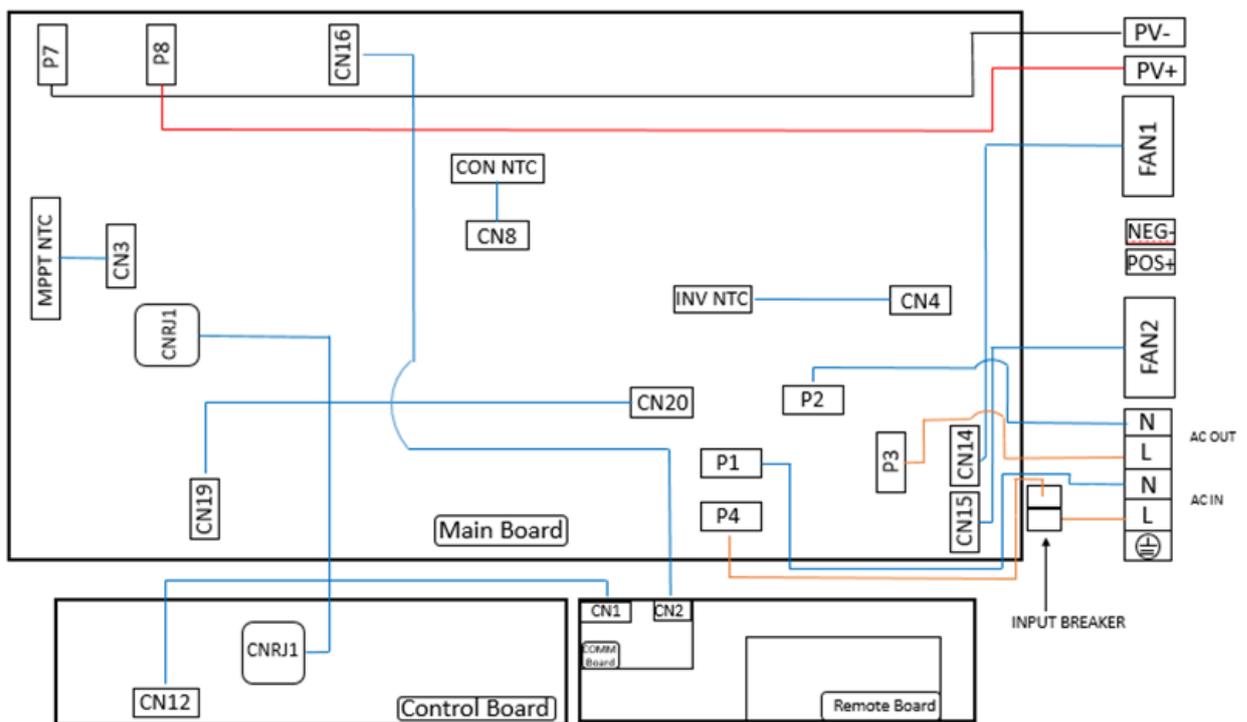
1.1 Total wiring diagram:

Note: Wrong connection of wires may cause inverter damage!
