Service Manual

AXPERT MAX II 8KW
Service manual

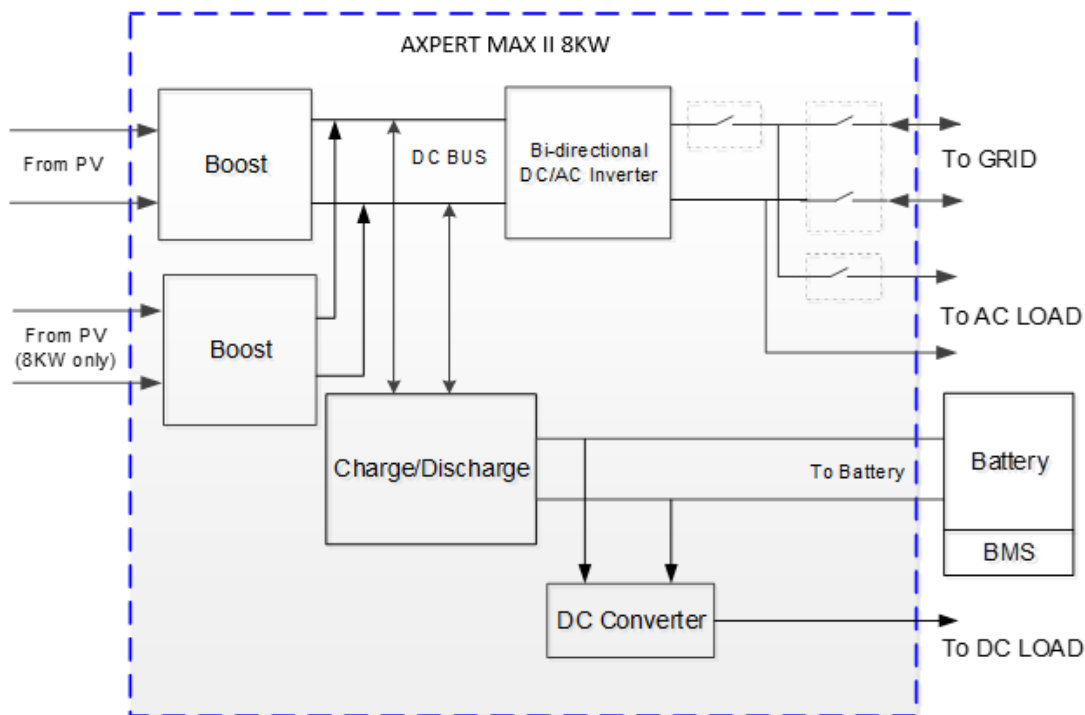
1.2 Basic topology introduction

The topology of the inverter shows as below:

Compare with UPS or normal inverter, INVERTER combines a solar charger inside. Solar charger can be a supplement for battery when there is not grid. And with the solar charger, the inverter can have more working modes than UPS. For detail information please refer to our user manual

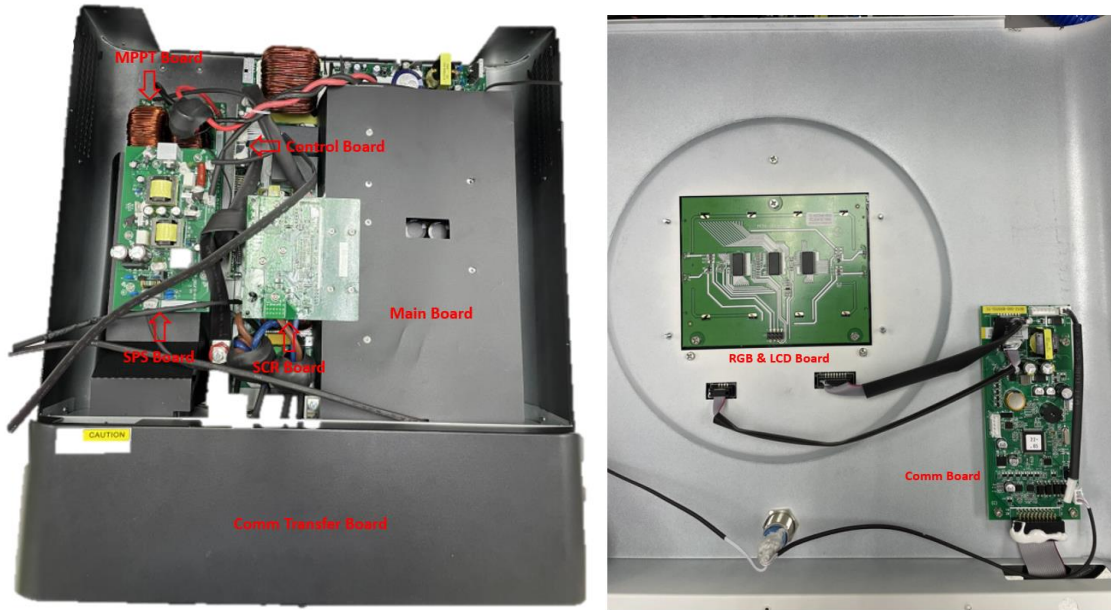
AXPERT MAX II 8KW

1.4 Overview the inverter

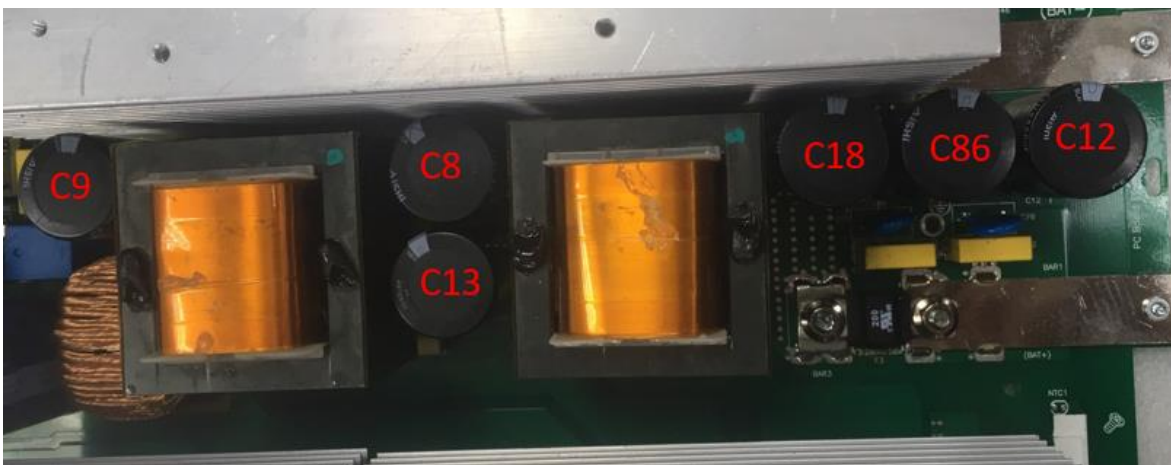
For AXPERT MAX II 8KW C8/C9/C12/C13/C18/C86: (6800uF 63V)

If the capacitors explode as below, they need to be replaced.

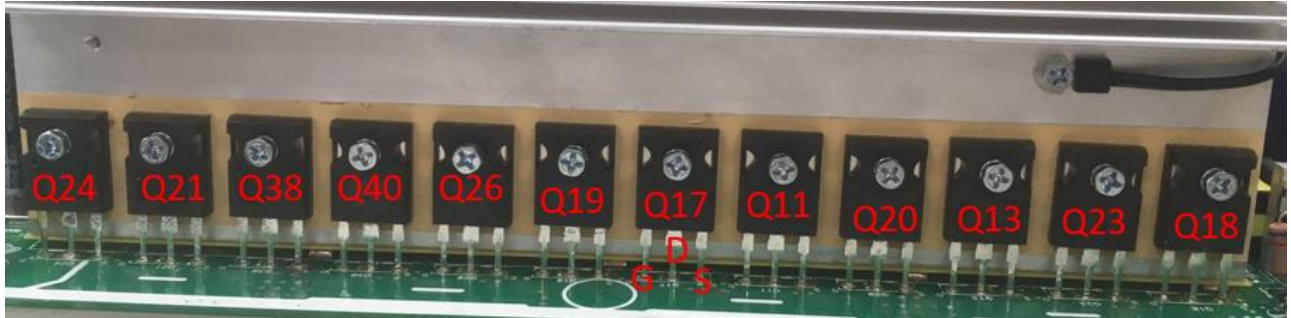
DC/DC MOSFET: Q24/Q21/Q38 & Q40/Q26/Q19 & Q17/Q11/Q20 & Q13/Q23/Q18

For AXPERT MAX II 8KW ALL of the MOSFET are (MOSFET IR/IRFP4668PBF 130A 200V N BULK TO-247)

Parts	Attribute	Reference values	Failure status
IRFP4668PBF	Resistor	GS: 15.67k GD: 510.0k DS: 581.0k	Short or explosion
	Diode	SD: 0.556V DS: OL

Note1: When you use the multimeter to measure the resistor of the transistor, because of the capacitor in the circuit, it will cause the changing of the values when you measure the DS and GD. So we recommend you measure the diode forward voltage of SD, and the resistor of GS. These two values can reflect the situation of the transistor more correctly.

Note2: If one or more of them were damaged, please replace all of them.

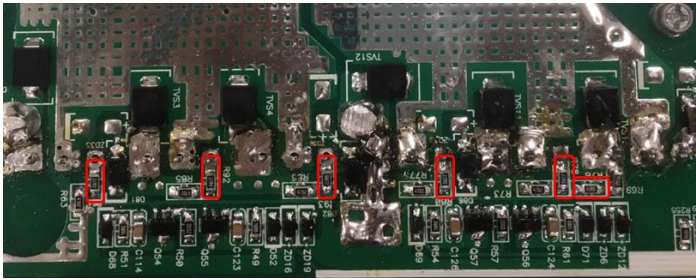
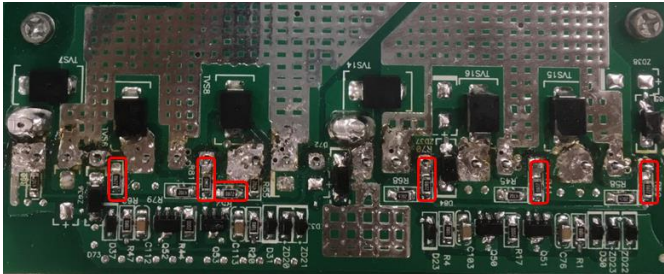
R76/R78/R80/R93/R92/R64

R59/R41/R70/R52//R81/R62 All of the resistors are (22R 1206)

Use multimeter to measure each resistor, find the burnt resistors and replace them; don't need to replace them all.

Parts	Attribute	Reference values	Failure status
All: 22ohm	Resistor	22 ohm	Open or other values

If the resistors need to be replaced, please also check the driver transistors and control IC.

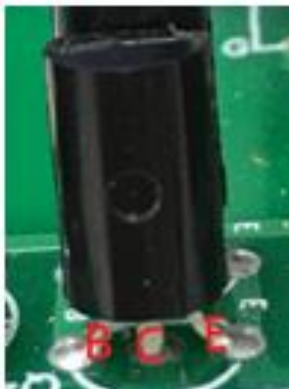
The Q46and Q48 are (TR UTC/2SC2655 2A 50V NPN TAP TO-92)

The Q47and Q49 are (TR UTC/2SA1020L-Y-T9N-B 2A 50V PNP TAP TO-92NL)

Parts	Attribute	Reference values	Failure status
Q46/Q48	Resistor	BE: 429.6k BC: 425.5k EC: 15.7k	Short or explosion
	Diode	BE: 0.65V BC: 0.65V EC: 0.28V	
Q41/Q43	Resistor	BE: 428k BC: 425k EC: 15.5k	Short or explosion
	Diode	BE: 0.65V BC: 0.65V EC: 0.28V	
Q47/Q49	Resistor	BE: 431k CB: 398k CE: 1.07k	Short or explosion
	Diode	BE: 0.65V CB: 0.63V CE: 0.17V	
Q15/Q16	Resistor	BE: 430k CB: 393k CE: 1.07k	Short or explosion
	Diode	BE: 0.65V CB: 0.60V

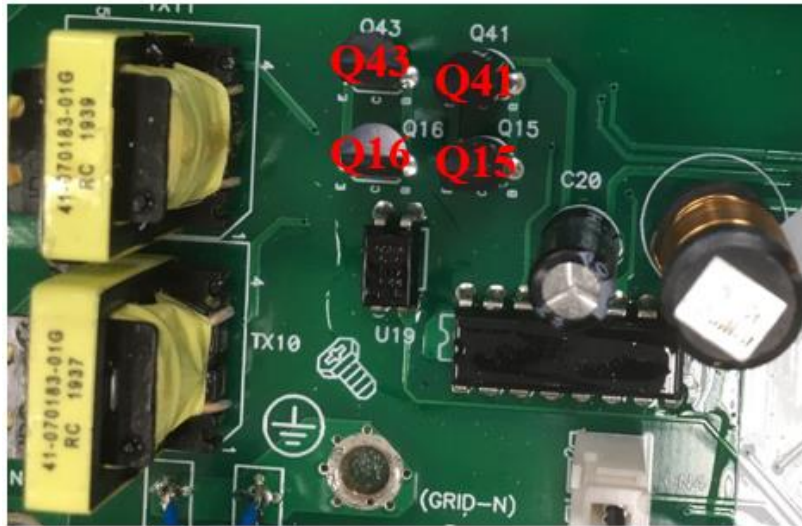
The Q41 and Q43 are (TR UTC/2SC2655 2A 50V NPN TAP TO-92)

The Q15 and Q16 are (TR UTC/2SA1020L-Y-T9N-B 2A 50V PNP TAP TO-92NL)

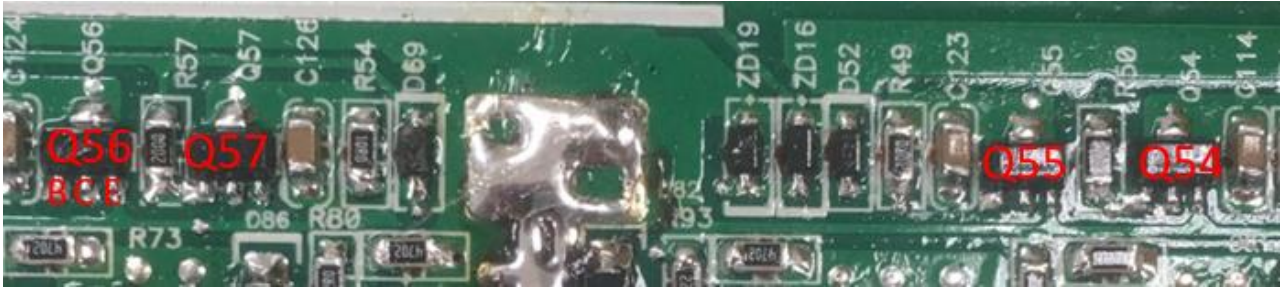
The Q54 and Q56 are (TR UTC/2SD1624 2A 50V NPN SOT-89)

The Q55 and Q57 are (TR UTC/2SA1020 3A 50V PNP SOT-89)

Parts	Attribute	Reference values	Failure status
Q54/Q56	Resistor	BE: 15.87k BC: 262.5k CE: OL	Short or explosion
	Diode	BE: 0.63V BC: 0.63V CE: OL	
Q55/Q57	Resistor	BE: 15.87k BC: OL CE: 276.6k	Short or explosion
	Diode	BE: 0.63V BC: OL CE: 1.11V

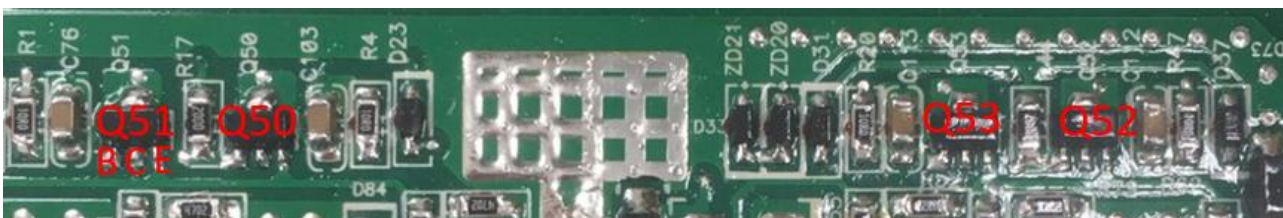
The Q51 and Q52 are (TR UTC/2SD1624 2A 50V NPN SOT-89)

The Q50 and Q53 are (TR UTC/2SA1020 3A 50V PNP SOT-89)

Parts	Attribute	Reference values	Failure status
Q51/Q52	Resistor	BE: 15.87k BC: 262.5k CE: OL	Short or explosion

Diode	BE: 0.63V BC: 0.63V CE: OL	
Q53/Q54	Resistor	BE: 15.87k BC: OL CE: 276.6k	Short or explosion
	Diode	BE: 0.63V BC: OL CE: 1.11V

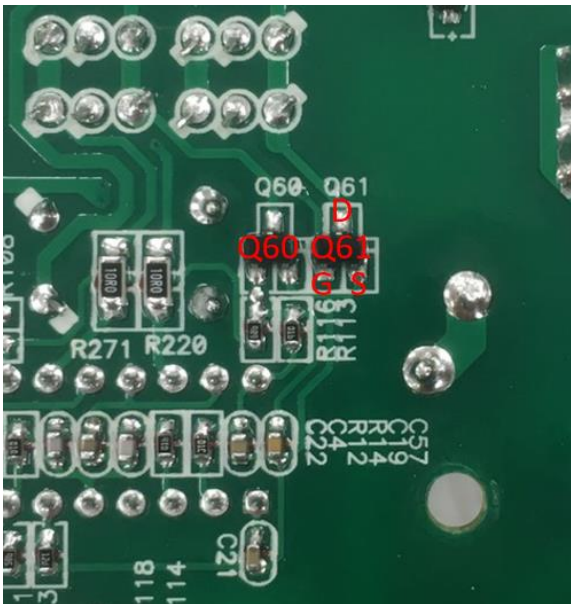
The Q60 and Q61 the MOSFET are (UT3404G 5.8A 30V NPN SOT-23 SMD)

Parts	Attribute	Reference values	Failure status
Q60/Q61	Resistor	GS: 4.123k GD: 9.58k SD: 1.12k	Short or explosion
	Diode	SD: 0.17V DS: 1.33V

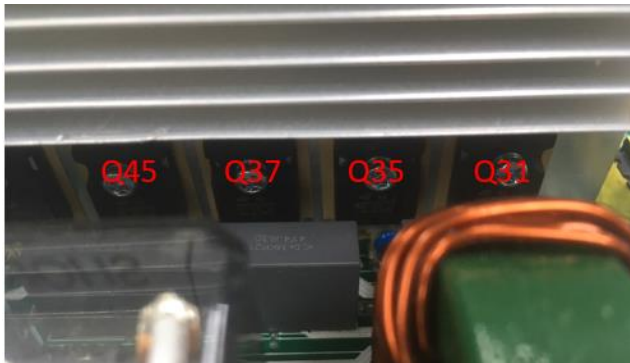
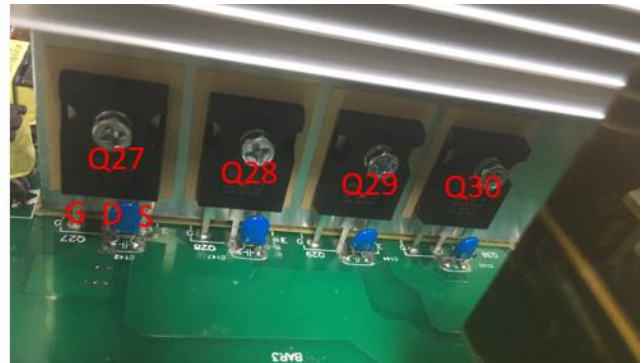
DC/DC IGBT: Q27/Q28/Q29/Q30/Q31/Q35/Q37/Q45

For AXPERT MAX II 8KW ALL of the IGBTs are (IGBT ST/STGW60H65DFB 60A 650V N BULK TO-247)

Parts	Attribute	Reference values	Failure status
Q27/Q28/Q29/Q30 Q45/Q37/Q35/Q31	Resistor	GE: 22.9 ohm GC: 169.4k EC: 169.1K	Short or explosion
	Diode	EC: 0.358V CE: OL

Note1: When you use the multimeter to measure the resistor of the transistor, because of the capacitor in the circuit, it will cause the changing of the values when you measure the CE and GE. So we recommend you measure the diode forward voltage of EC, and the resistor of GE. These two values can reflect the situation of the transistor more correctly.

Note2: If one or more of them were damaged, please replace all of them.

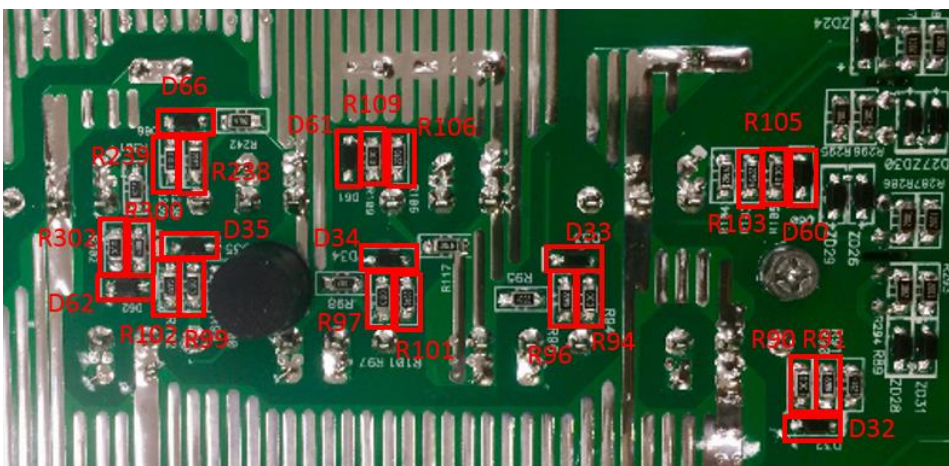
R91/R103/R102/R300/R96/R106/R101/R238: (22R 1206)

R90/R105/R99/R302/R94/R109/R97/R239: (0R 1206)

D32/D60/D35/D62/D33/D61/D34/D66: (1N4148W 0.15A 75V SMD)

Parts	Attribute	Reference values	Failure status
R91/R103/R102/R300/ R96/R106/R101/R238	Resistor	22 ohm	Open or other values
R90/R105/R99/R302 /R94/R109/R97/R239	Resistor	0 ohm	
D32/D60/D35/D62/ D33/D61/D34/D66 ¹	Resistor	+ to -: 270k - to +: OL	Short or explosion
	Diode	+ to -: 0.6V - to +: OL

Note1: When test the diode; please remove the R90/R99/R94/R97 from the board, or the test result is not right.

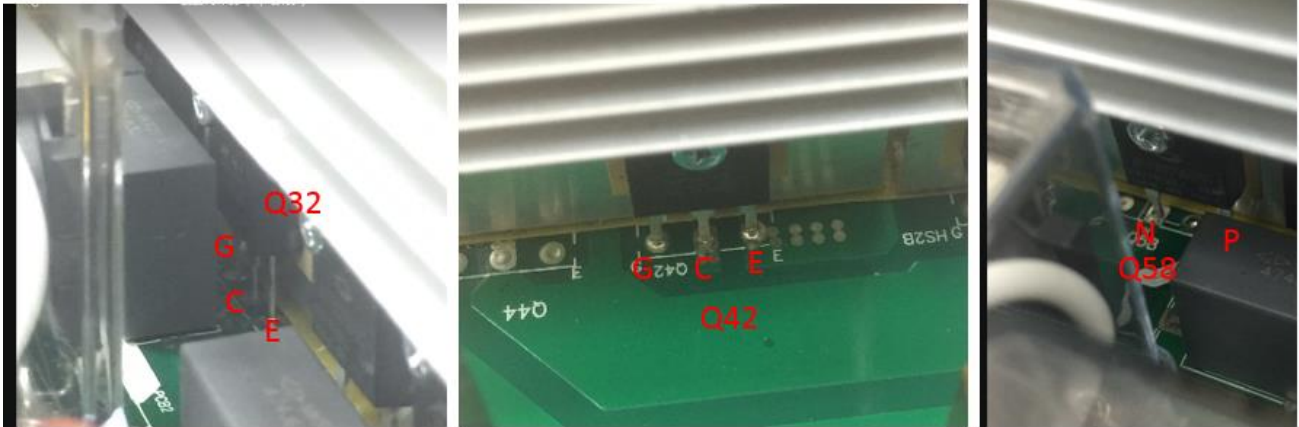
BUCK MOSFET and Diode:Q32/Q42/Q58

For AXPERT MAX II 8KW the IGBTs Q32 /Q42 are (IGBT ST/STGW60H65DFB 60A 650V N BULK TO-247)

The Q58 is (APT/30DQ60BG 30A 600V UFST RAD TO-247 BULK)

Parts	Attribute	Reference values	Failure status
Q32/Q42	Resistor	GE:17.07k GC: 209.3k CE: OL	Short or explosion
	Diode	CE: OL EC: 0.393V	
Q58	Resistor	+ to -: 193.9k - to +: OL	
	Diode	+ to -: 0.383V - to +: OL

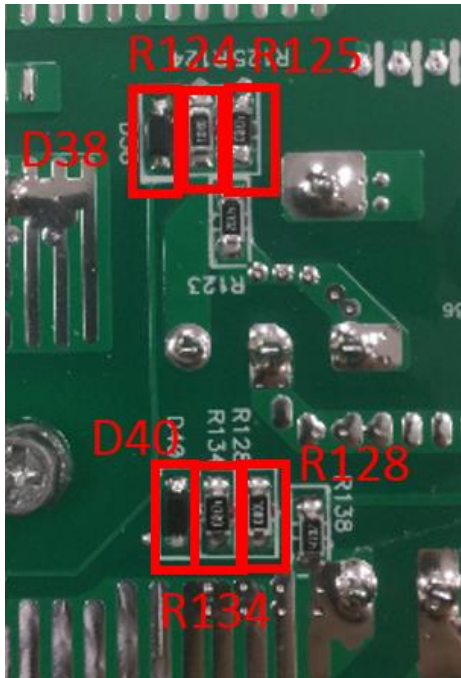
The R124/R128 are (10R 1206)

The R125/R134 are (47R 1206)

The D38/D40 are (1N4148W 0.15A 75V SMD)

Parts	Attribute	Reference values	Failure status
R125/R134	Resistor	47 ohm	Open or other values
R124/R128	Resistor	10 ohm	
D38/D40 ¹	Resistor	+ to -: 240k - to +: OL	Short or explosion
	Diode	+ to -: 0.6V - to +: OL

Note1: When test the diode; please remove the R124/R128 from the board, otherwise the test result is not right.

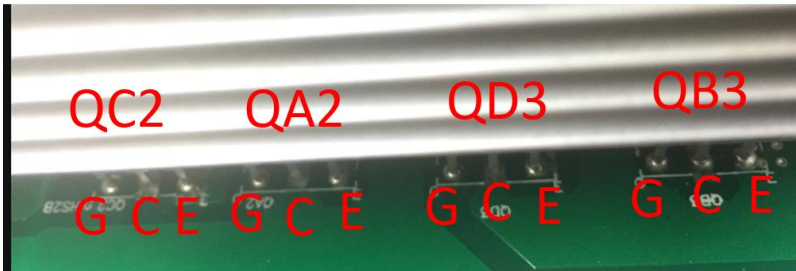
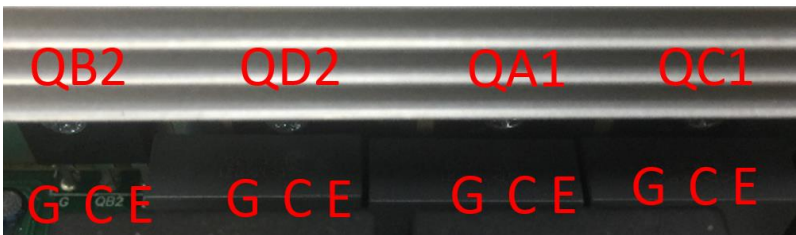
INV IGBT: QA1/QA2/QC1/QC2/QB2/QB3/QD2/QD3

All of the IGBT are (STGW60H65DFB 60A 650V N BULK TO-247)

Parts	Attribute	Reference values	Failure status
QA1/QA2/QC1/QC2/ QB2/QB3/QD2/QD3	Resistor	GE: 17.59k GC: 208.1k EC: 183.7k	Short or explosion
	Diode	EC: 0.378V CE: OL

Note1: If one or more of them were damaged, please replace all of them.

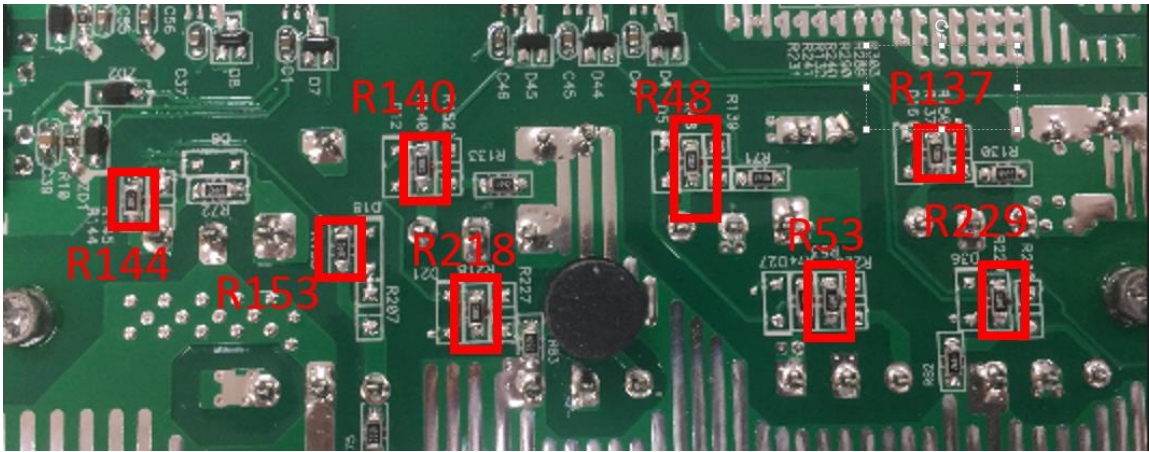
R48/R53/R144/R153/R140/R218/R137/R229: (30R 1206)

Parts	Attribute	Reference values	Failure status
R48/R53/R144/R153/ R140/R218/R137/R229	Resistor	30 ohm	Open or other values

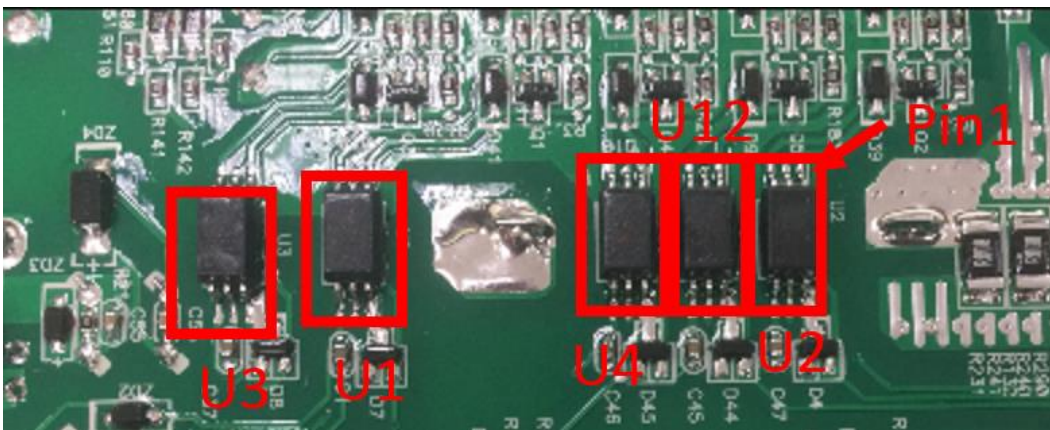
Optocoupler: U1/U2/U3/U4/U12

ALL of the optocoupler are (TI/UCC23513DWYR 6/SOIC SMD)

Parts	Attribute	Reference values	Failure status
U1/U2/U3/U4/U12	Diode	PIN4 TO PIN5: 0.63V PIN4 TO PIN6: 0.425V	Short or explosion
U2/U4/U12/ U1/U3	Resistor	PIN4 TO PIN5: 198.4k PIN4 TO PIN6: 160.7k

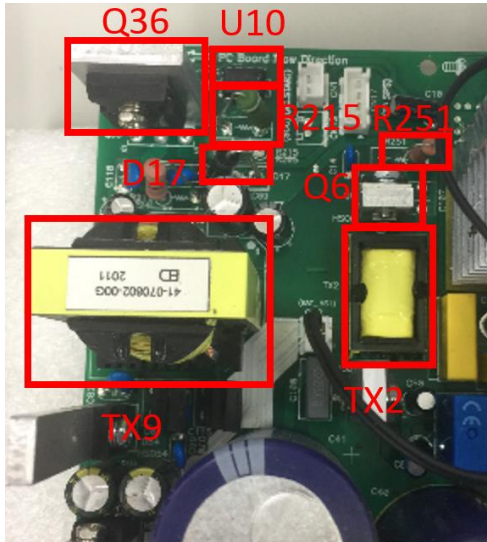
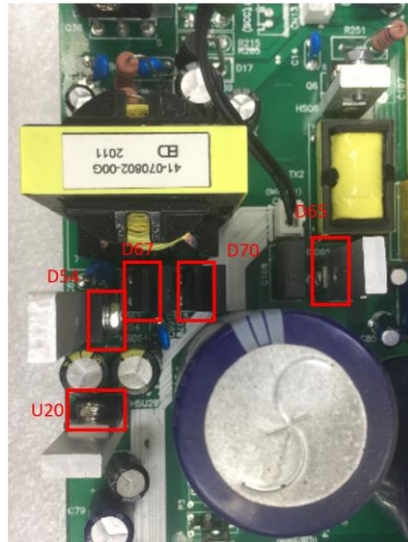
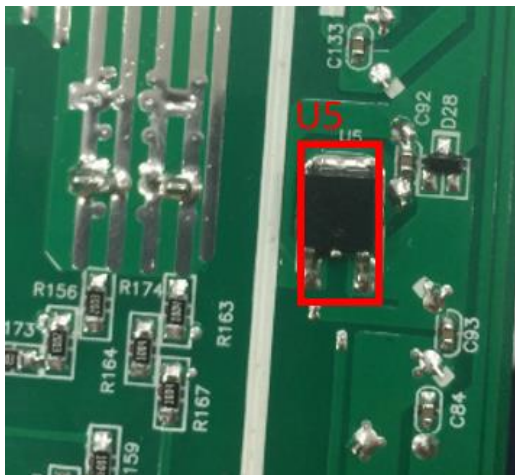
BATT Power SPS&Main Power SPS

The Q36 is (MOSFET IR/IRFP4227PBF 46A 200V N BULK TO-247)

The Q6 is (MOSFET IR/IRF840 8A 500V N BULK TO-220)

The U10 is (IC PWM CNTL ON/UC3845BNG DIP-8)

The D17 is (D IO/HER303 3A 200V UFST AXI DO-27 TAP)

Parts	Attribute	Reference values	Failure status
Q36	Resistor	SD: 275K SG: 16.4k	Short or explosion
	Diode	SD: 0.46V SG: 0.65V	
Q6	Resistor	SD: 275k SG: 1.17k	Short or explosion
	Diode	SD: 0.46V SG: 0.29V	
U10	Diode	PIN5 TO PIN7: 0.48V	Short or explosion

PIN5 TO PIN6: 0.64V	
D17	Diode	+ to -: 0.45V - to +: OL	Short or explosion
TX9	Resistor	PIN1 TO PIN3: 0.2 ohm	Short or other values
TX2	Resistor	PIN2 TO PIN4: 2.7 ohm	Short or other values
R215	Resistor	0.15 ohm	Open or other values
R251	Resistor	0.62 ohm	Open or other values
D65	Diode	+ to -: 0.448V - to +: OL	Short or explosion
D70	Diode	+ to -: 0.457V - to +: OL	Short or explosion
D67	Diode	+ to -: 0.458 V - to +: OL	Short or explosion
D54	Diode	+ to -: 0.384V - to +: OL	Short or explosion
U20	Diode	PIN G TO PIN I: 1.96V PIN G TO PIN O: 1.36V	Short or explosion
U5	Diode	PIN G TO PIN I: 0.45V PIN G TO PIN O: 0.98V	Short or explosion

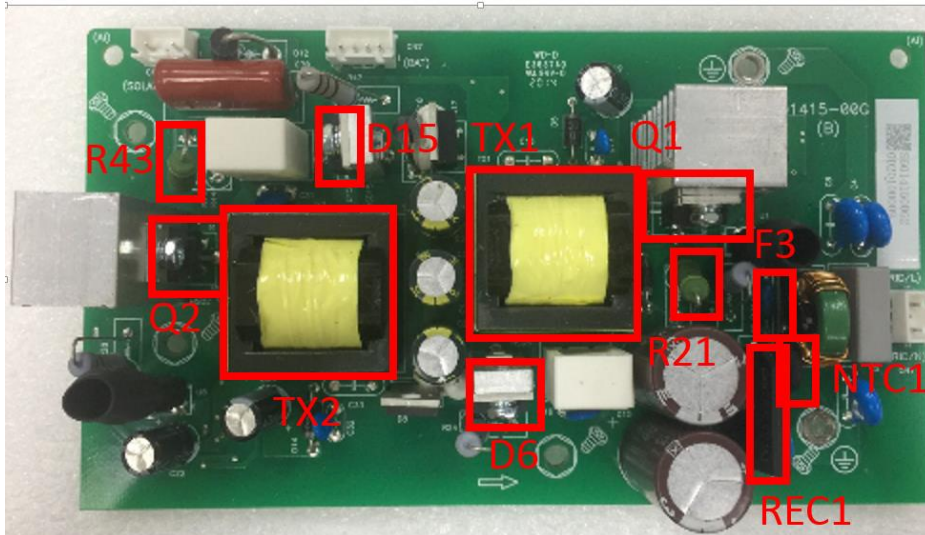
3.6 Check AC SPS and PV SPS

The F1 is (FUUSE 3A 250V)

The Q1 is (SPP11N80C3 11A 800V)

Parts	Attribute	Reference values	Failure status
F1	Resistor	0.2 ohm	Open or explosion
NTC1	Resistor	9.9 ohm	
Q1	Resistor	SD: 212.2K SG: 15.55k	Short or explosion
	Diode	SD: 0.42V SG: 0.31V	
TX1	Resistor	PIN1 TO PIN3: 0.4 ohm	Short or other values
R21	Resistor	0.47ohm	Open or other values
D6	Diode	+ to -: 0.428V - to +: OL	Short or explosion
Q2	Resistor	SD: 229.9K SG: 15.61k	Short or explosion
	Diode	SD: 0.417V SG: 0.301V	
TX2	Resistor	PIN1 TO PIN3: 0.3ohm	Short or other values
R43	Resistor	0.47ohm	Open or other values
D15	Diode	+ to -: 0.429V - to +: OL	Short or explosion

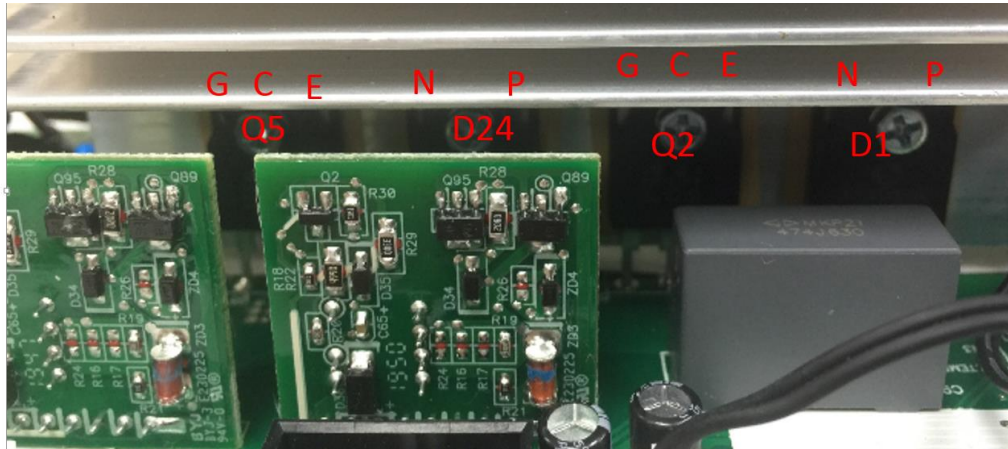
Boost IGBT Q2/Q5 and Diode D1/D24

The D1 and D24 are (30DQ60BG 30A 600V TO-247)

The Q2 and Q5 IGBT are (STGW80H65DFB 80A 650V N BULK TO-247)

Parts	Attribute	Reference values	Failure status
Q2, Q5	Resistor	GE: 41.17k GC: 233.5k EC: 183.5k	Short or explosion
	Diode	EC: 0.382V CE: OL	
D1,D24	Diode	+ to -: 0.381V - to +: OL

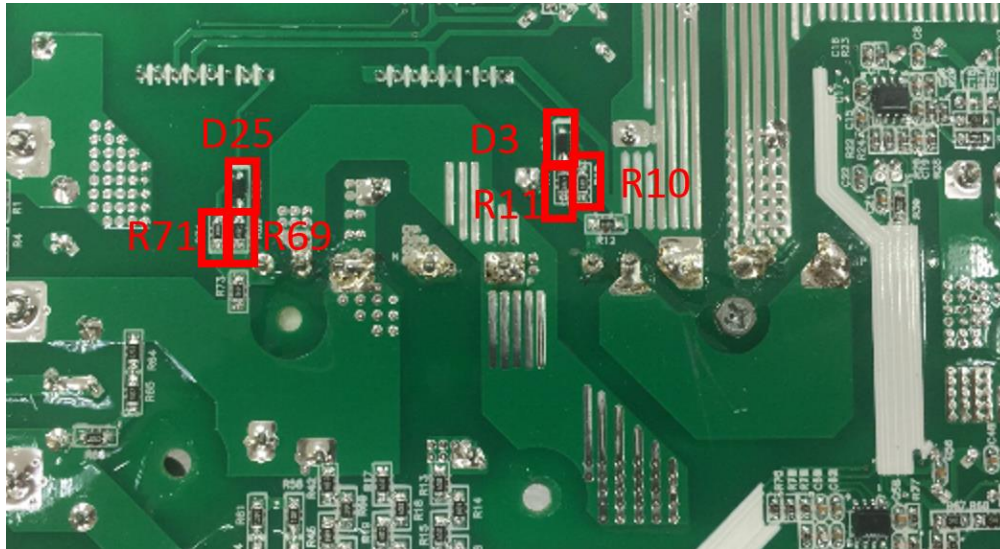
The D3 and D25 are (1N4148W 0.15A 75V SMD)

The R10 and R71 are (30R 1206)

The R11 and R69 are (47R 1206)

Parts	Attribute	Reference values	Failure status
D3/ D25 ¹	Diode	+ to -: 0.6V - to +: OL	Short or explosion
R10/ R71	Resistor	30 ohm	Open or other values
R11/ R69	Resistor	47 ohm	Open or other values

Note 1: When test the diode; please remove the R11/ R69 from the board, or the test result is not right.

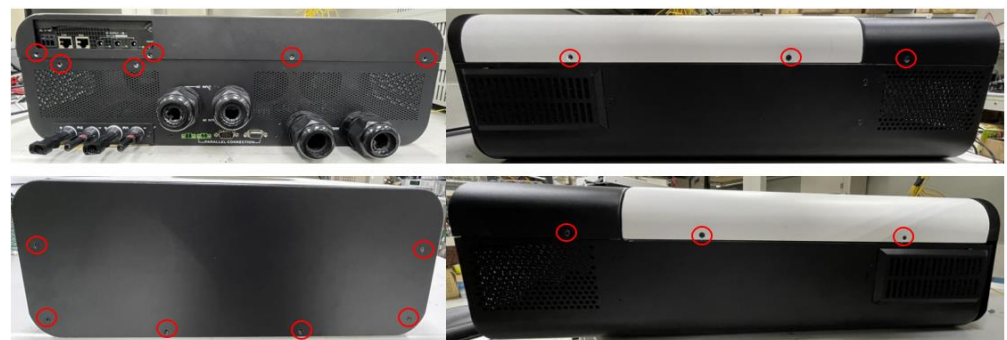
Remove 18 screws on top cover and rear panel.

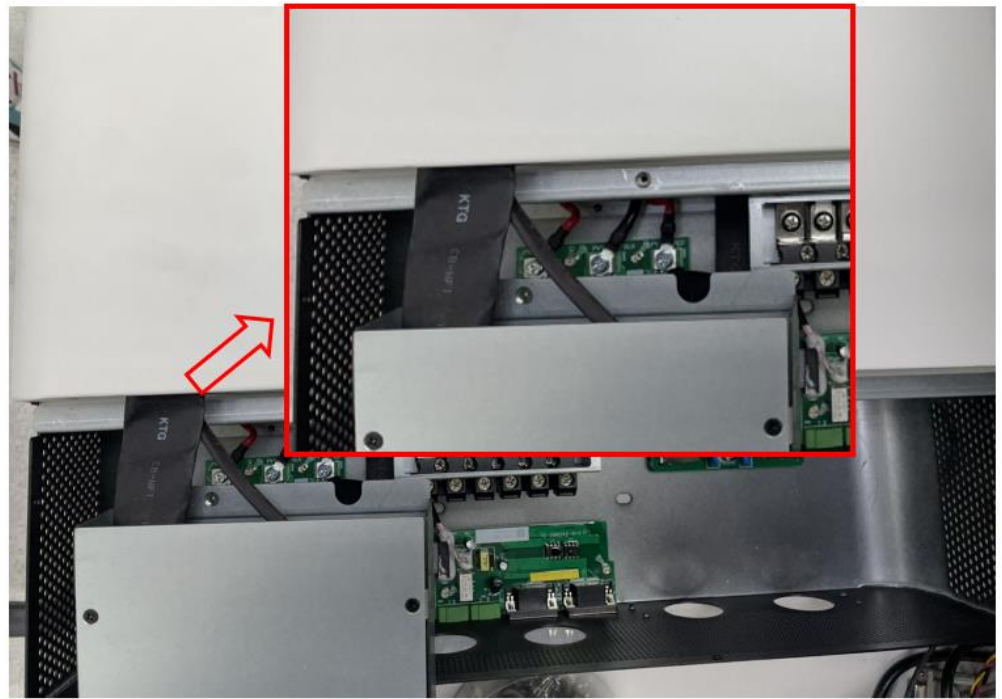
Remove the remote panel and control cables.

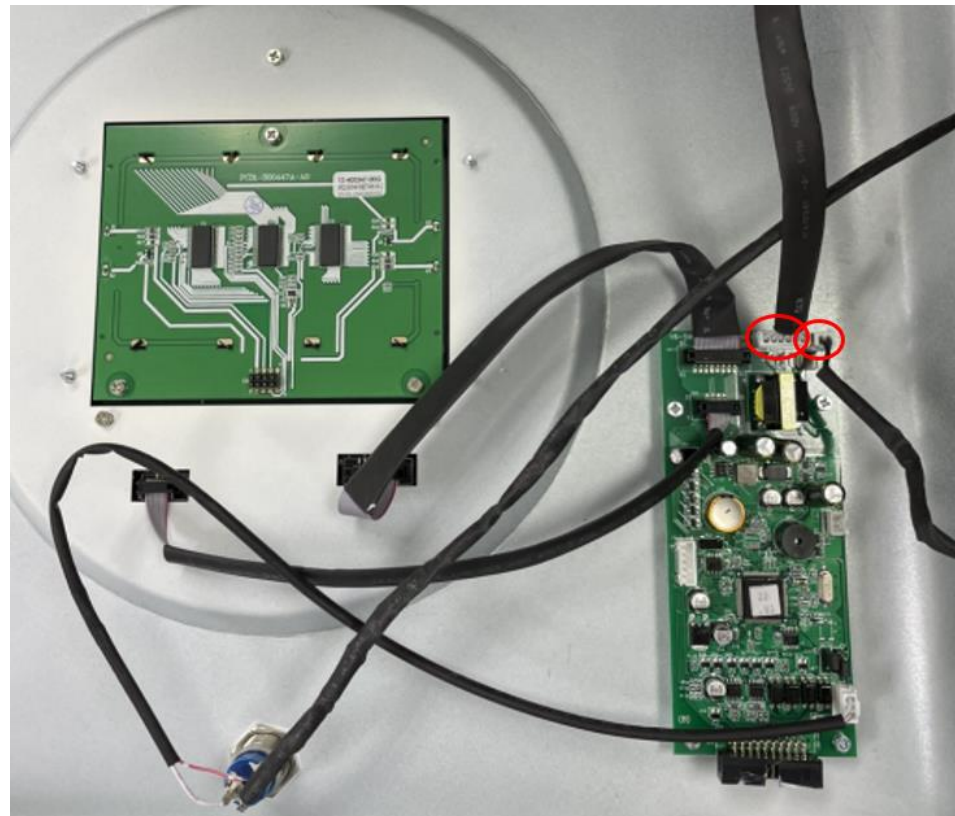
Remove the 2 control cables.

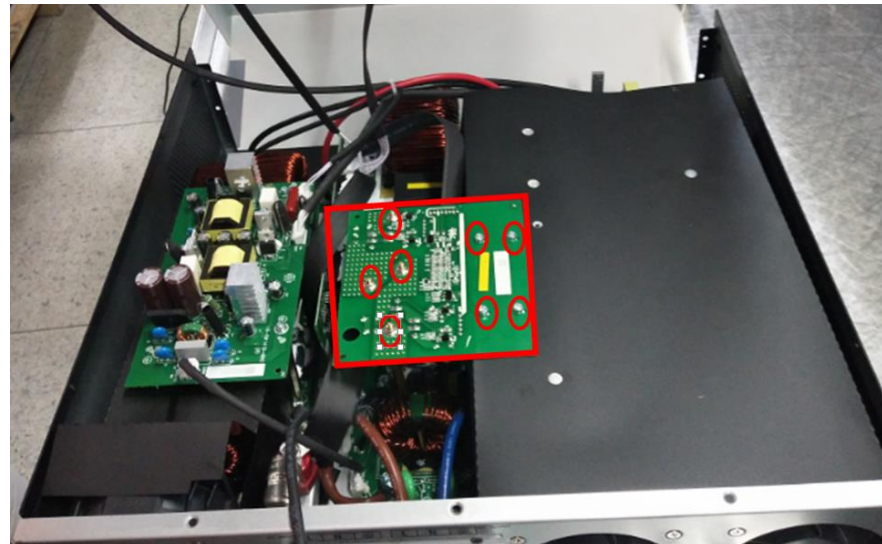
Remove 4 screws and 4 nuts on the SCR Board.

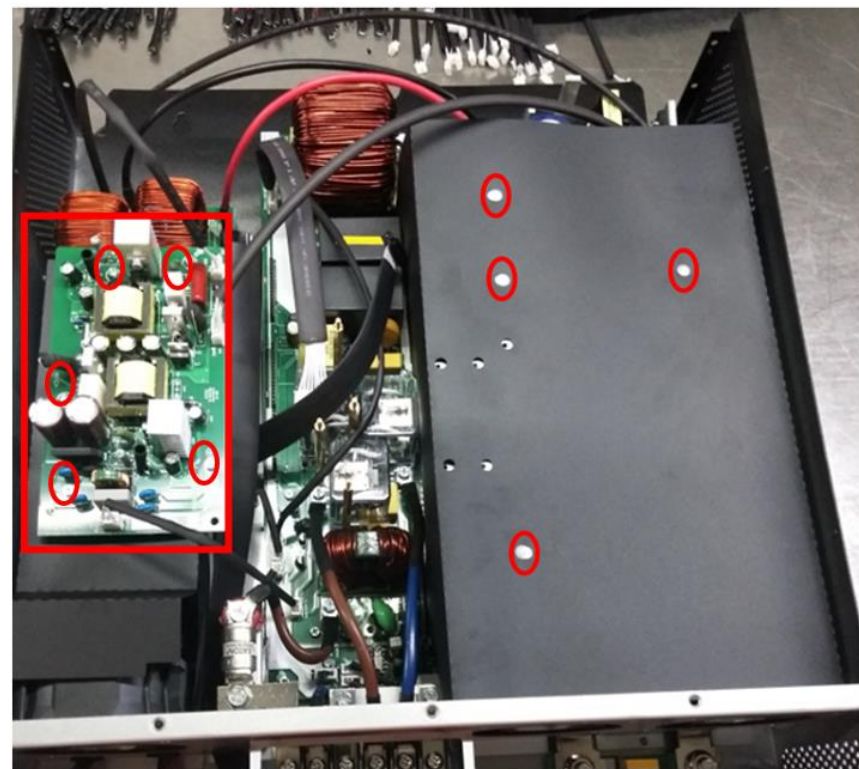
Remove 5 screws on the SPS Board ,and 4 plastic screws of wind pipeline.

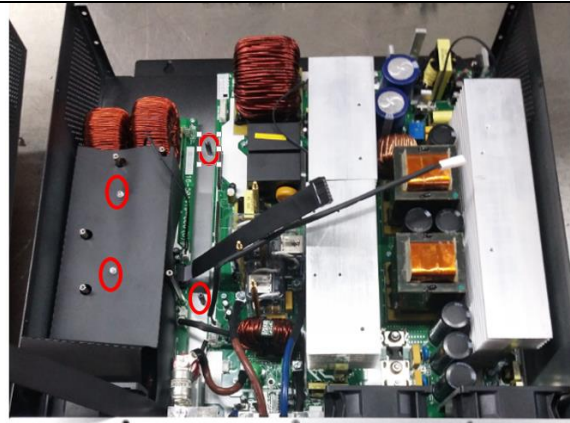
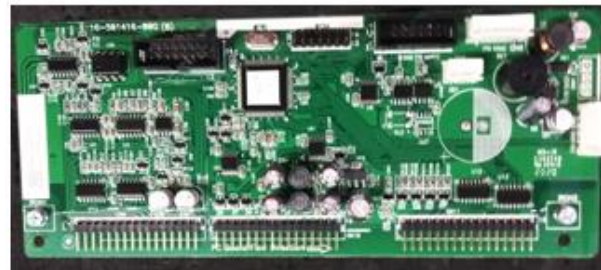
Remove 2 plastic screws of wind pipeline and 2 screws beside the control board. Take out the control board.

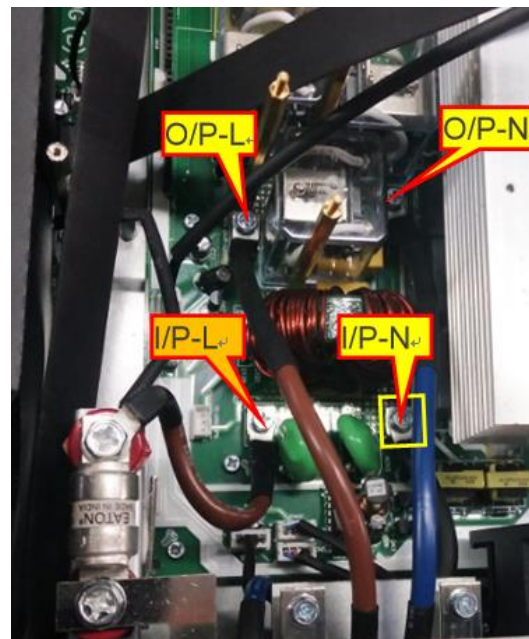
Remove I/P and O/P cables.

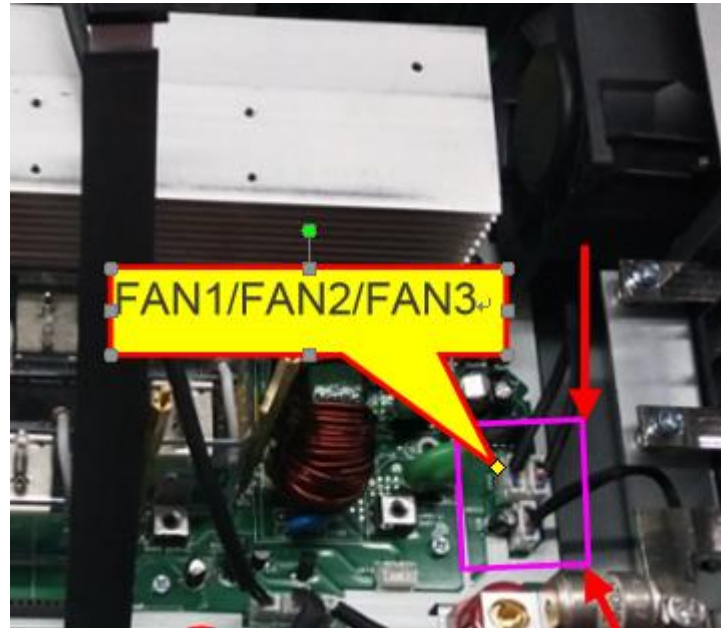
Remove the fan cables.

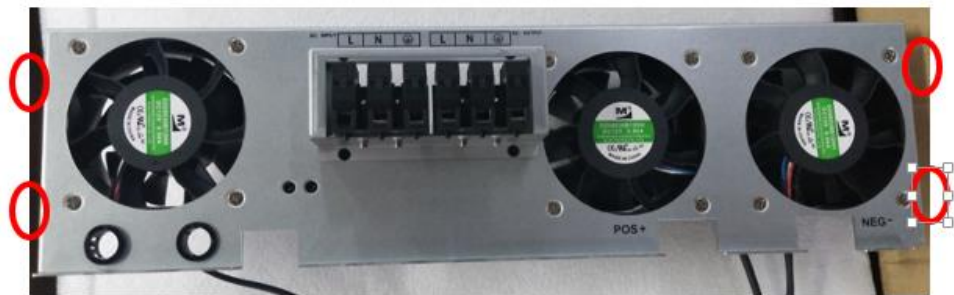
Remove 4 screws beside the fan frame.

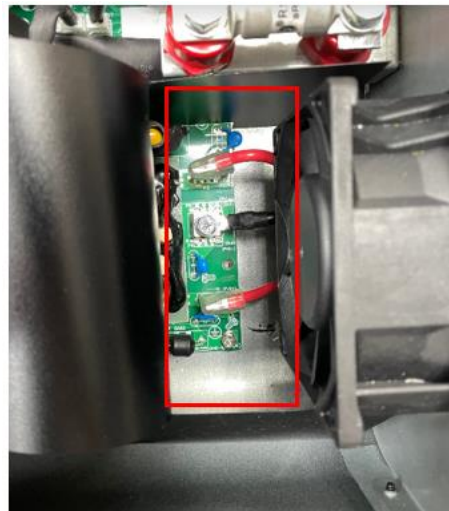
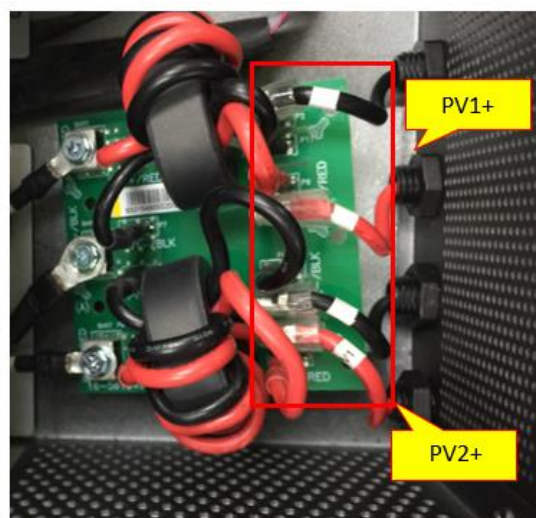
Remove PV IN cable.

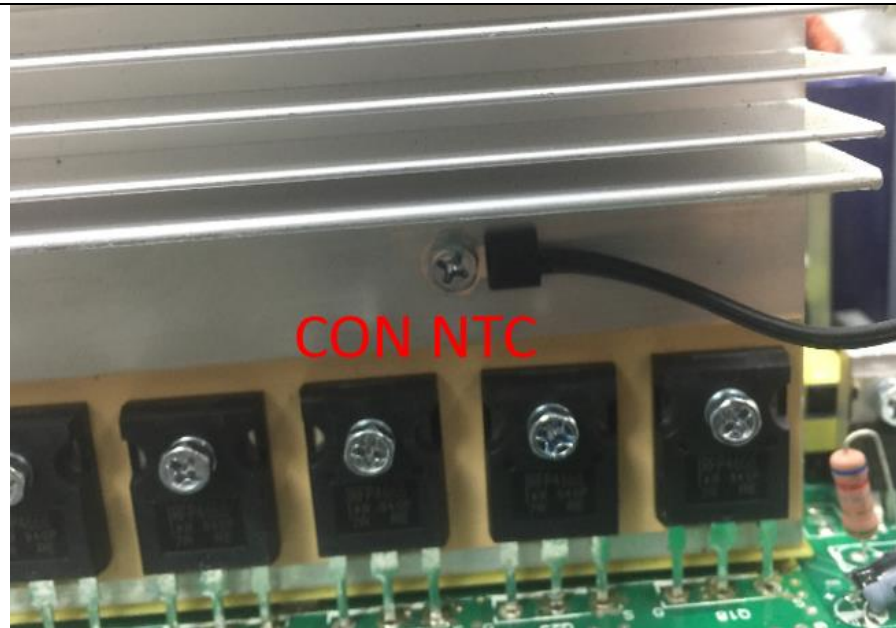
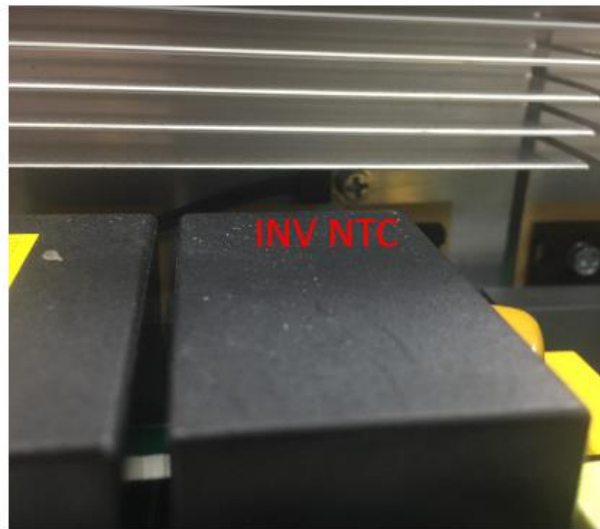
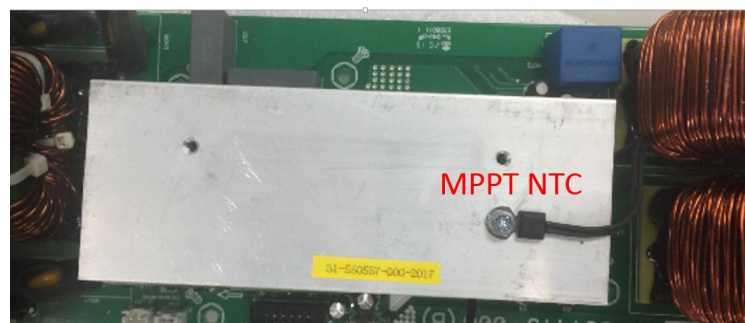
Remove MPPT
NTC, Converter
NTC and INV
NTC.

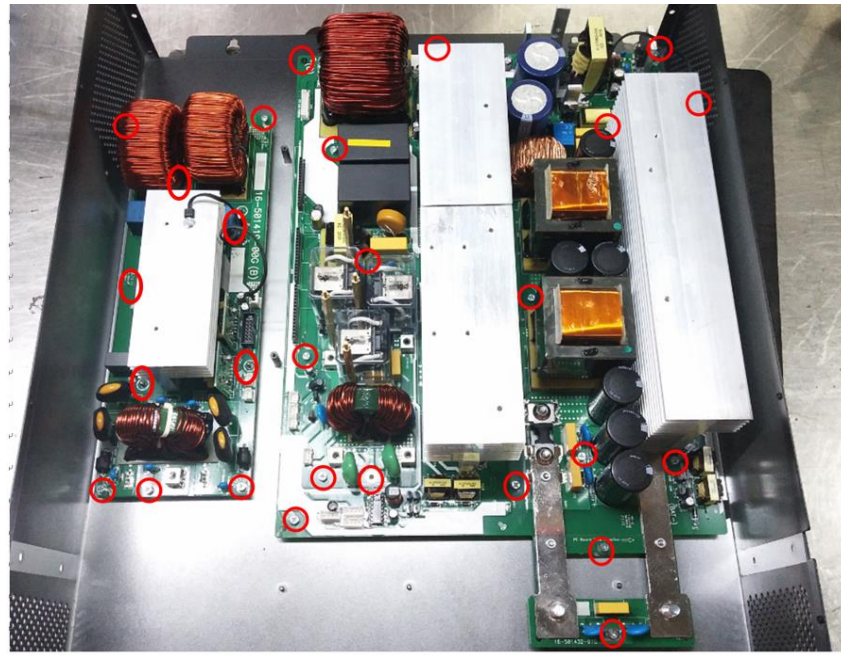
Remove 22
screws on main
board and
MPPT board.
Remove 5
copper pillars
on MPPT

board.
Take out the
main board and
MPPT board.
